A case study on a fire-induced collapse accident of a reinforced concrete frame-supported masonry structure

Keywords: Frame-supported masonry structure; fire-induced collapse; site investigation; numerical simulation

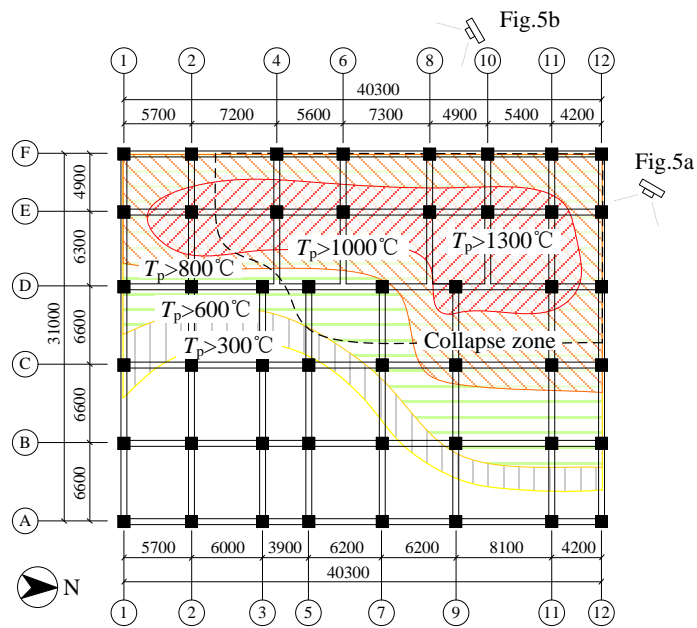
Figure 3 Temperature distribution and collapsed area

An accurate time-history of the temperature distribution within the building was not recorded due to the lack of warning about the fire incident and the unavailability of a measurement tool. Such a tool had not been used in the small city for more than a decade. However, the fire related data was deduced from the site investigation and the laboratory test on the materials post-fire. The steel samples exposed to the fire were tested by the National Analysis Center for Iron and Steel (NACIS) of China using the metallographic analysis method^[32]. The test report indicated that the reinforcing steels in some of the structural components were over-sintered but not melted. Given that the sintering and melting temperatures of reinforcing steels are 1250 °C and 1500 °C, respectively, the highest temperature of steel was deduced to have between these two values. Further, based on the test data of the steel samples from different locations within the building, the temperature distribution on the ground floor of the building was determined, as shown in Figure 3. About 45.9% of the bottom RC frame suffered a high temperature in excess of 800°C (the area was 573.46m² of the floor area 1249.3m² (=45.9%)). Due to congestion by the surrounding buildings (Figure 4), it

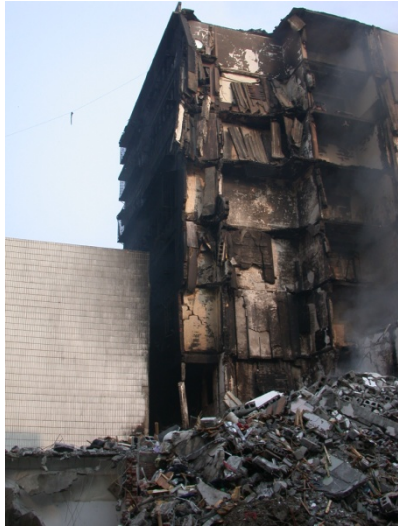
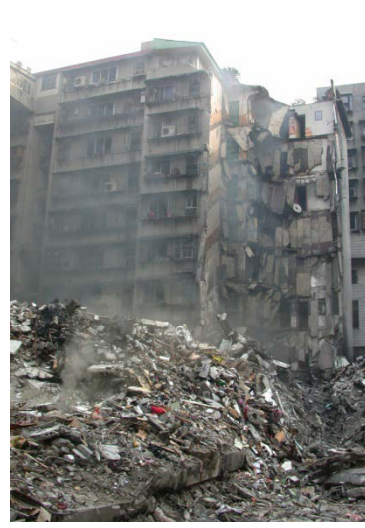
Figure 5 The collapse scene

was very challenging for the firefighters to spray water directly onto the fire, especially from the west and north sides of the building. After approximately three hours of fire, the entire north-west region of the building collapsed. The collapsed zone of the building was, in general, consistent with the high-temperature zones. A range of photos of the collapsed building are given in Figure 5, with specific viewpoints shown in Figure 3.

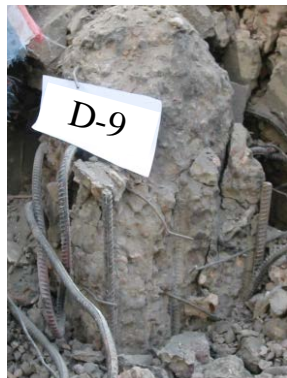
(a) Column D-9

Figure 6 shows the fire damage to the columns, whose locations are illustrated in Figure 2. The crushed concrete and brownish steel surface of Column D-9, located at the center of the fire, indicated that the cross-section of the concrete column suffered severe high-temperature damage. Column E-2, located on the border of the high temperature area, suffered spalling of the concrete, buckling of the longitudinal reinforcement, and compressive failure as clearly shown in Figure 6(b).

Based on the degree of damage to the columns and beams, the preliminary site investigation concluded that damage of Columns E-8, E-10, E-11, D-9, and D-11 on the ground floor (refer to Figure 1) occurred due to very high temperature exposure, which is believed to have triggered the progressive collapse of the upper masonry structure. The columns were designed to resist a normal fire in accordance with the requirements of the design code ^[33], regulated for commercial buildings. However the occupation of the ground floor of the building was changed to a warehouse filled with a large amount of flammable materials. Hence, the actual fire load developing at the time of the accident was extremely high, higher than originally considered acceptable in the design. The extraordinary fire load, covering a large area with a very high temperature, is considered to be the primary reason for the initial damage to the ground floor columns. In addition, the spalling of the concrete cover, and the construction error at the connections between the slabs and the RC frame, all accelerated the damaged to the columns.

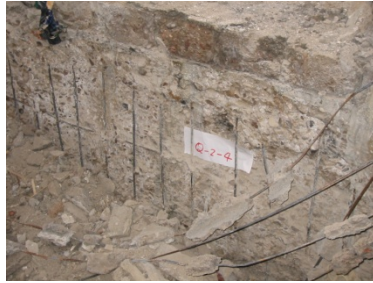
(a) Beam 8-E~F

Figure 7 shows severe damage to the beams located at the center of the fire. The concrete cover of Beam 8-E~F (refer to Figure 2) fell off, causing the exposure of the stirrups and the longitudinal reinforcing steel. Subsequent to the collapse of Beam

10-D~E, the reinforcing steels were exposed, and some degree of spalling was observed. The metallographic analysis of the reinforcement indicated that the highest temperature of the steel was between 1250 °C and 1500 °C, as described above.

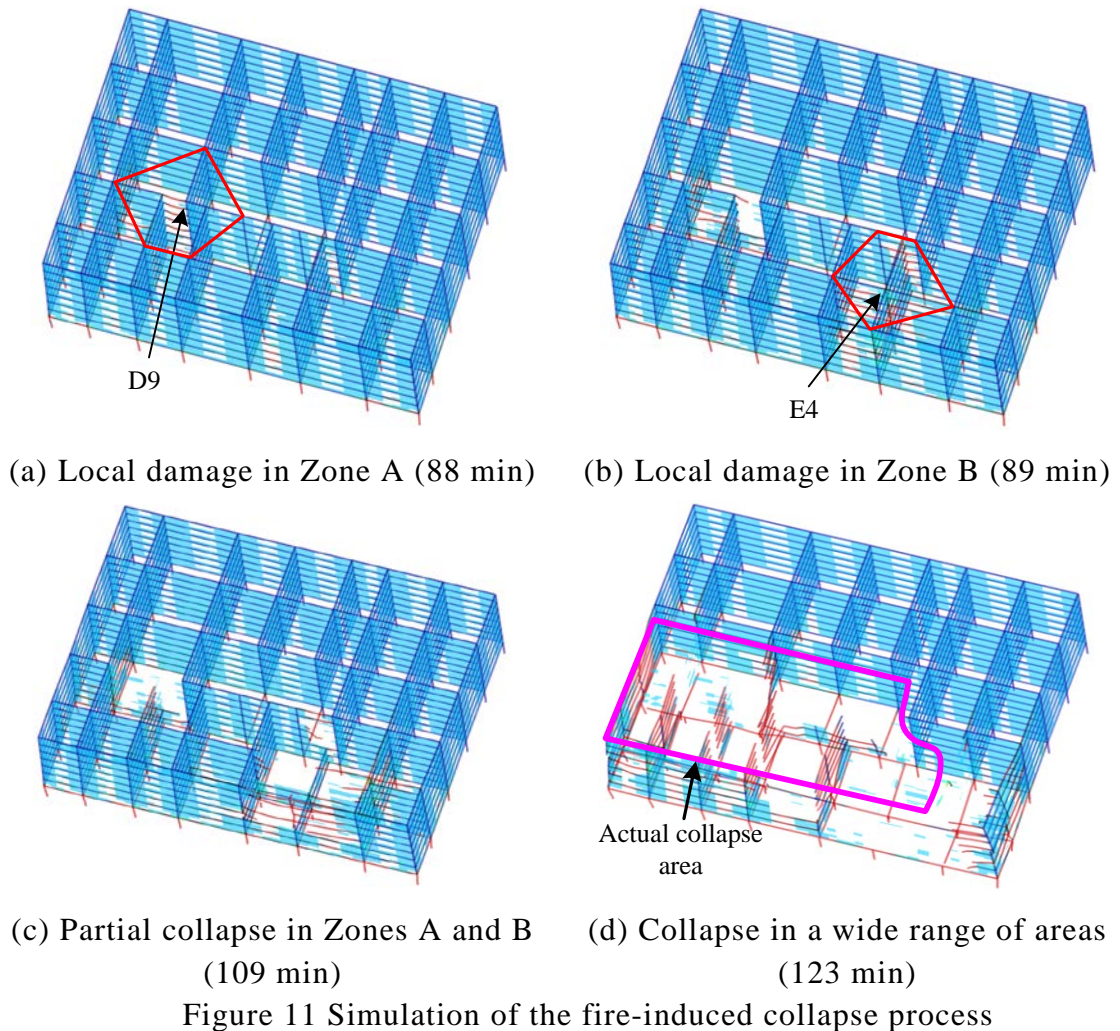
The simulated collapse process of the structure is shown in Figure 11. As the fire developed, the bottom Columns, D9 and E4, located at the center of Zones A and B (see Figure 12), were damaged first. This damage resulted in a significant vertical displacement in the two zones and, subsequently, lead to damage in the upper

masonry walls (Figures 11a and 11b). As the fire developed further, an initial collapse occurred in Zones A and B (Figure 11c), which altered the load transfer path of the entire structure and triggered the collapse of the adjacent areas, as shown in Figure 11d. A comparison of Figure 11d and Figure 3 demonstrates that the simulated collapse area agrees well with the actual one. Moreover, only damages in Zone A were observed from the site investigation, whereas damages in Zone B were identified from the numerical simulation. This outcome implies that numerical simulation is a powerful analysis tool for fire safety research. In the current numerical study, a total of 23,742 elements were used; this involved five hours computational time on a single CPU desktop. The proposed modeling method was highly efficient.

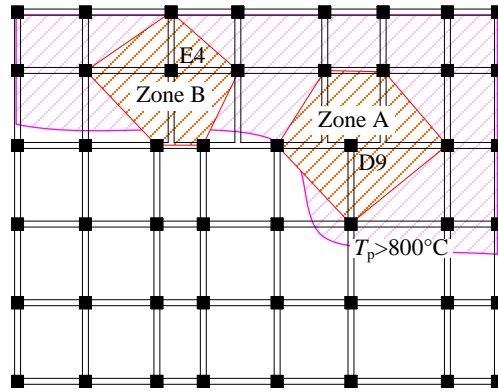
Figure 12 The load area borne by the initially damaged columns

The simulated collapse process revealed that the initial cause of the progressive collapse was the destruction of Columns D9 and E4, located at the center of Zones A

and B (see Figure 12). The collapse occurred due to the following three factors. First, the fire temperature in these zones was significantly higher (greater than 800 °C) than the other regions. As shown in Figure 3, Columns D9 and E4 reached a maximum temperature of 1300 °C. Therefore, the fire damage to these two zones was more severe than in the remaining part of the structure. Two, the structural planar layout for Columns D9 and E4 carried a larger gravity load than did the other components (the shaded part of Figure 12), making them more vulnerable to fire. Third, the structural arrangements of Zones A and B were more complex than those of the other areas. The gravity load of the upper walls (4-E~D and 10-E~D), initially acting on the secondary beams, was transferred to the main girders (3~5-D and 9~11-D), and then to the columns. Thus, these structural elements appeared to exhibit more complicated internal force characteristics which were more vulnerable to damaged under the fire condition. Taking Beam 9~11-D and its parallel Beam 9~11-C in Zone A as an example, the vertical displacements and the mechanisms of these two beams, shown in Figure 13, had an identical longitudinal span (8.1m) and supported the slabs with similar widths (12.9m and 13.2m). This situation lead to near uniformly distributed gravity loads q acting on the beams. However, an additional concentrated load P transferred from the upper Wall 10-E~D also acted on Beam 9~11-D. As a result, larger internal forces (i.e. shear force and bending moment) developed in Beam 9~11-D in comparison to Beam 9~11-C, and, in turn, induced a lager deformation, as shown in Figure 13. Moreover, the displacement of Beam 9~11-D reversed at about 88 min.; this was due to the load redistribution of the adjacent columns as a result of the high temperature actions (discussed in the following section). Given the abovementioned reasons, Zones A and B were the most vulnerable regions within the structure to initiate a collapse under fire.

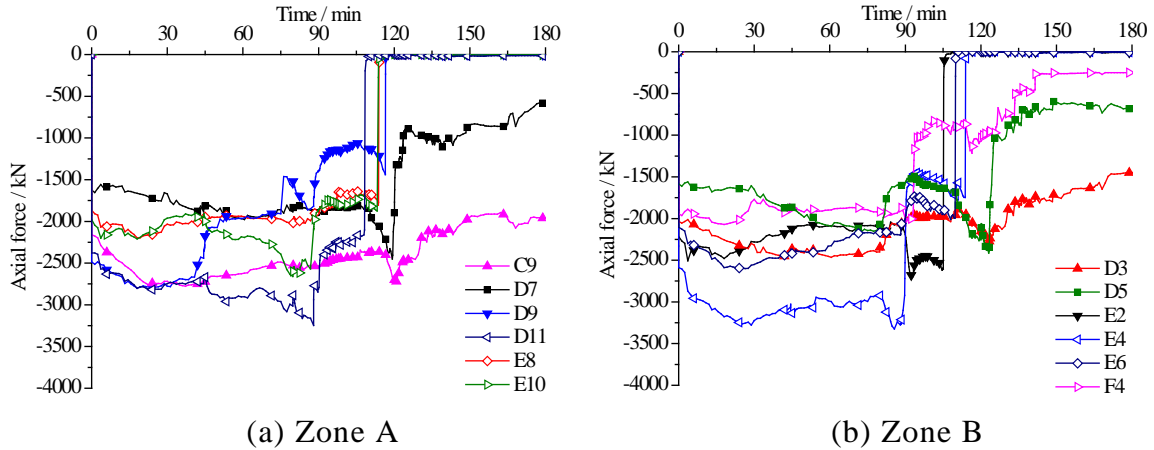
Figure 14 Axial forces of the frame columns

The axial forces of the columns in Zones A and B, obtained by the numerical simulation, are shown in Figure 14. In the initial stage of fire (0-30 min.), the thermal expansion of the ground floor columns was restrained by the upper structure, leading to increased axial forces for all the columns affected by the fire. After 47 min. more damage to Column D9, at the center of Zone A, reduced its internal axial force, which led to the redistribution of the internal forces. The axial forces then began to increase correspondingly in Columns E10 and D11. Reaching 88 min. of fire, the columns adjacent to Column D9 began to become damaged due to the redistributed incremental load and the fire-induced strength degradation, resulting in a rapid collapse in Zone A (Figure 11a). Subsequently, the axial forces in Columns D11, E8 and E10 decreased to zero. Column D7, located at the boundary of the collapsed areas,

remained connected to the residual structure; thus its capacity was not completely lost. Column C9, which was outside of the collapsed zones, was not destroyed either, but its axial load decreased because the gravity load of the residual structure was reduced by the collapsed region.

According to the above analysis, after Column D9 in Zone A was damaged, the gravity load, which was originally supported by Column D9, was redistributed to the surrounding columns, including D11, E8, and E10. At this stage, the structure was considered robust enough to resist fire because of the efficient alternative load path provided by D11, E8, and E10. However, the surrounding columns consequently failed due to the strength degradation induced by the continuing development of the fire and the increased gravity load. Such a failure resulted in an insufficient capacity of the alternative load path in the structural system; this, in turn, led to the initial collapse of Zone A. Therefore, the primary reason for the structural collapse was the weakening of the resistance of the structure due to excessive fire load and very high temperature over a large area. Neither of these aspects are considered in the Chinese fire design code^[33]. Further, the collapse mechanism of Zone B was similar to that of Zone A, as indicated by Figure 14b; however, it was not repeated here.

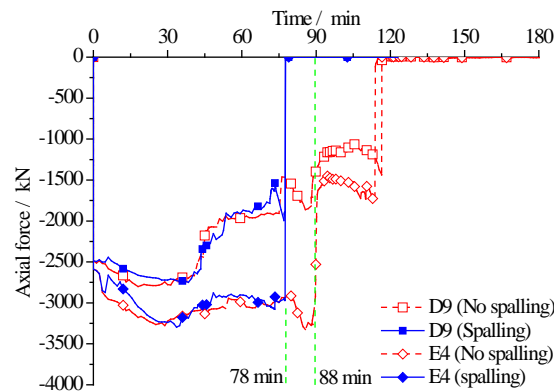
Figure 15 Effect of concrete spalling on the axial forces of the frame columns

simulation, taking into account the spalling phenomenon, was performed herein. For the reason given in Section 4.1.1, a simplified model of concrete spalling, proposed by Kodur et al.^[48], was incorporated in the fiber beam element. In this model, the concrete spalling occurred when the temperature of the concrete exceeded 350 °C. Subsequently, the contribution of the spalled concrete to the strength and stiffness of the structural elements was not considered in the numerical model. The simulated collapse process, taking into account concrete spalling, was found to be almost identical to that where the spalling effect was not considered, as shown previously in Figure 11. However, a comparison of the time history curves of the axial forces of Columns D9 and E4 (Figure 15) revealed that the collapse time of the building was reduced from 88 min to 78 min when spalling was considered. This appears to have occurred as the spalling reduced the effective sectional area of Columns D9 and E4 which, in turn, accelerated their strength deterioration and shortened their failure time. In addition, the concrete spalling also resulted in a sudden loss of the axial forces in Columns D9 and E4 when the collapse occurred. The outcome seems to have resulted from the fact that the spalling reduced the compressive capacities of the columns under fire, thereby weakening the load redistribution capacity.
