A CASE STUDY OF A CORRODED CAST IRON WATER MAIN ON BRIDGE RD, RICHMOND

A.J Spark^{1,2}, D O’Keefe³, I Cole¹, A.M Osborn², D Law² & L.P Ward²

CSIRO¹, Melbourne, Australia, RMIT University², Melbourne, Australia & City West Water³, Melbourne, Australia

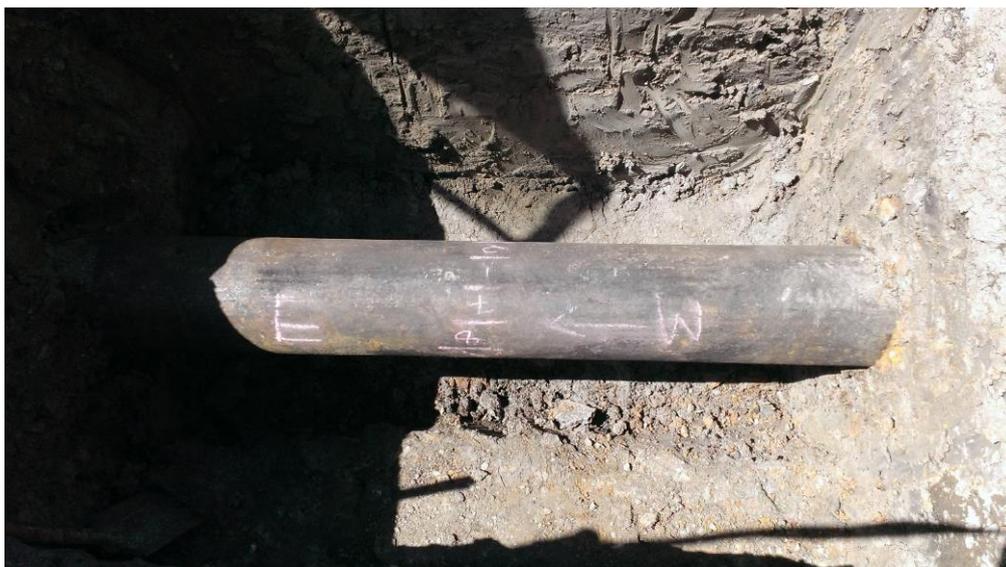
Figure 1: Photo of excavated pipe

In December 2014, a section of water main located at Bridge Rd in Richmond, Victoria was exposed via excavation of the surrounding soil as part of CWW's condition assessment program (Figure 1). MFL data was collected on site and soil samples taken for soil analysis. Additional soil samples and samples of the corrosion product scraped from the external surface of the in service pipeline were taken for further investigations to identify whether microbial species were present. By comparing MFL results, soil analysis data and microbial data, the aim is to give a more complete understanding of the environment surrounding a pipe, the condition of the pipe and how this may contribute ultimately to pipe failure.

Visual inspection showed the pipe to be in good condition, especially for its age, with some faint regions of orange corrosion product present on the external surface. As the pipe had been wiped down prior to the inspection to remove all remnant of soil, it is possible that more obvious signs of corrosion had been removed.

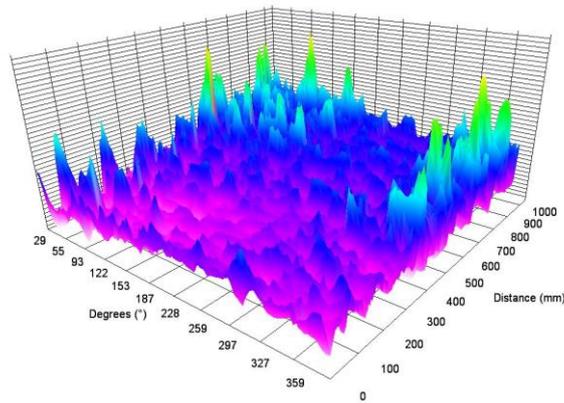
Figure 2: MFL Scan Plot

Results from the MFL scan (Figure 2) show significant pitting corrosion has occurred across certain regions of the pipe section investigated. The most severe pitting all occurs within a 100° quadrant across the pipes circumference as shown in Figure 3 which corresponds with the crown of the pipe, road side. The ten worst defects recorded (Table 2) are all through wall corrosion defects. Axial location refers to distance along the pipe of the one metre section scanned. Orientation refers to position around the pipe with 0° being the top of the pipe.

The report identified the ten worst defects along the pipe interface all of which were through wall pits. Many of these defects were concentrated on the crown of the pipe along the 1m length, with the only one not on the crown of the pipe being located at 93°. The disparity in defect size detected between the precursor ultrasonic scan and the MFI scan suggests a limitation in one or both techniques and that multiple techniques should be used to get an accurate understanding of the condition of an asset. The finding that all ten of the worse defects in the pipe are on the top half of the pipe and that the bottom of the pipe is relatively free of significant pitting suggests that there has been water flow on the bottom of the pipe (16, 17). Due to compaction of the soil directly below a pipeline, the bottom of a pipe is an area where water will collect as it struggles to flow further down, especially after heavy rain fall. This would reduce the oxygen concentration along the bottom of the pipe and also decrease the number of triple phase boundaries along this section of the pipe leading to a decrease in corrosion rate (3). While there was no visual evidence of this during the site inspection, the pipe was excavated below the level of the pipe so this may have been missed. The soil above the pipe where the worst defects are clustered would be the least compacted, so that this area would have the most porous structure allowing water to flow freely through the soil, leading to oxygen levels being readily replenished (18). This would increase the corrosion rate on the crown of the pipe.

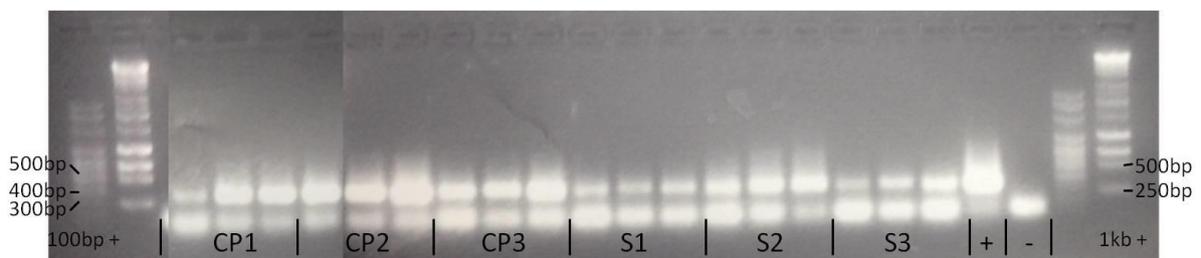
Each of the amplicon solutions were verified by gel electrophoresis. When matched against sizing ladders (HyperLadder 1kb plus and HyperLadder 100bp plus) the amplified DNA were shown to be in the range of 300bp, as expected. There was also no contamination of the amplification process. This indicates DNA was successfully extracted from both the soil samples and, more uniquely, the corrosion product scrapings.

Figure 4: Image of gel electrophoresis results showing consistently sized amplicons and no contamination
