**Closure to 'Severe Damage of a Pile Group due to Slope Failure' by
D. E. L. Ong, C. F. Leung, Y. K. Chow, and T. G. Ng**

2016

Journal of Geotechnical and Geoenvironmental Engineering

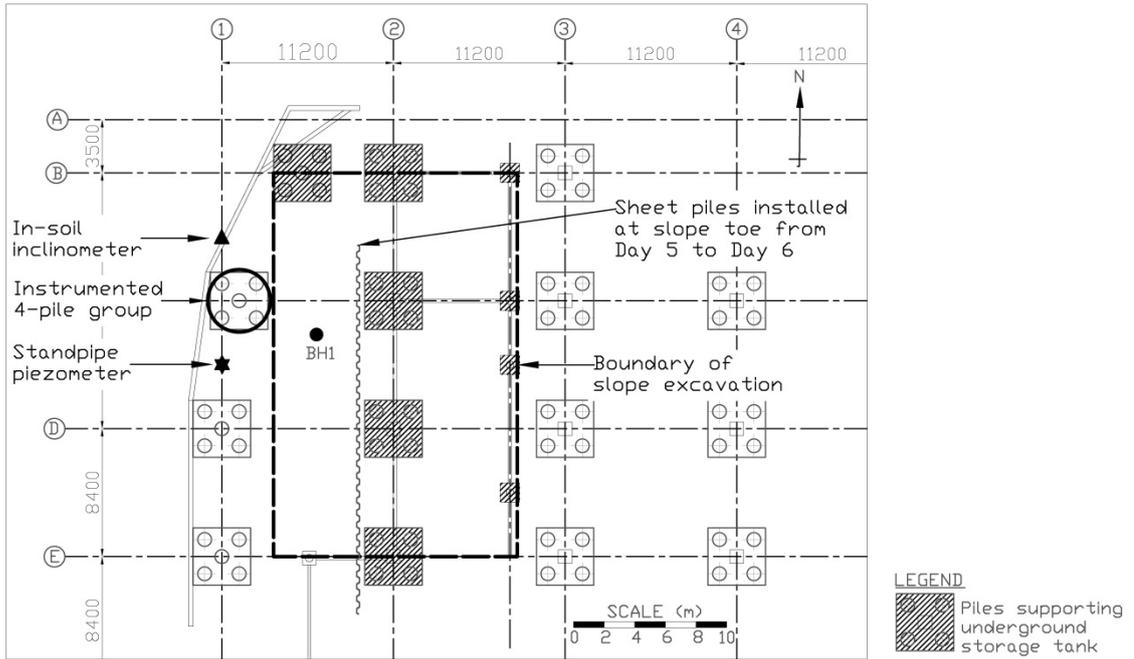
Fig 1

75 2. The locations of the piles supporting the underground water storage tank and
76 sheet piles in relation to the boundary of the slope excavation are now re-
77 emphasized in Fig. 1 for greater clarity.

Fig. 1. Plan view showing the locations of instruments, instrumented pile group and piles supporting the underground storage water tank at the site

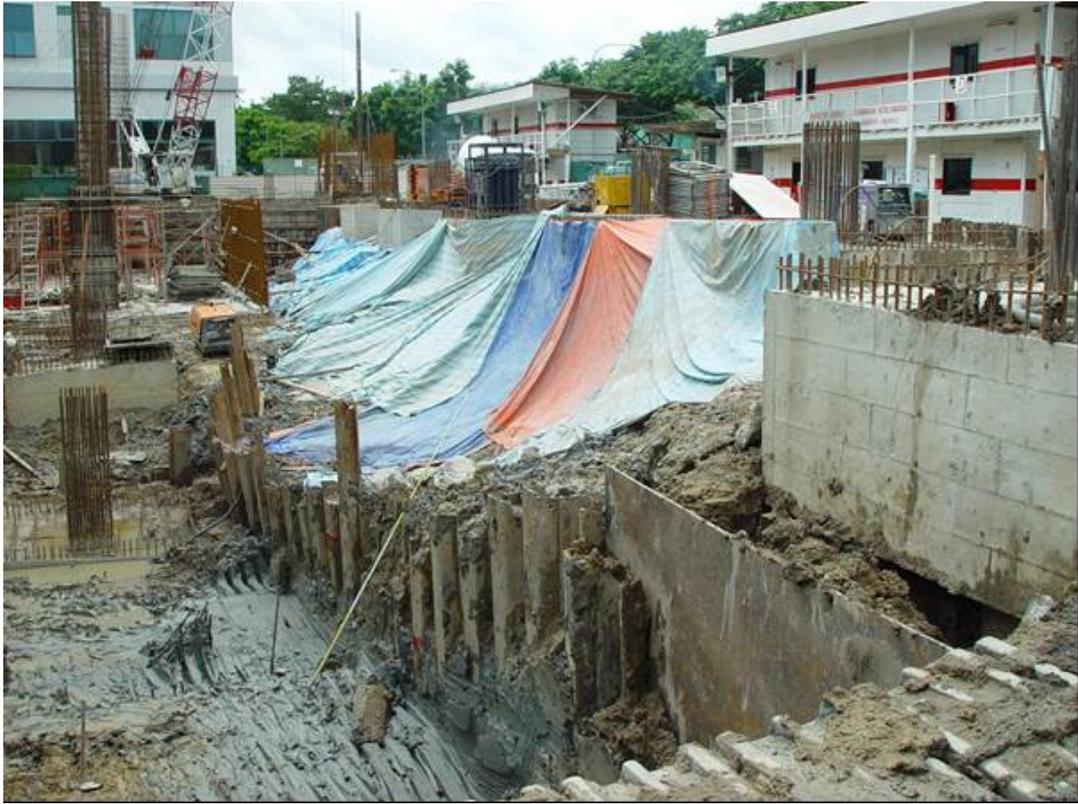
Fig 2

48 increasingly tilted cantilever sheet pile wall as shown in Fig. 2 and also as recorded by
49 the adjacent in-soil inclinometer as shown in Fig. 7 of Ong et al. (2015) until Day 62,
50 despite the installation of waling and strutting system on Day 19 to brace the
51 cantilever wall. Fig. 3 shows the improved representation of the construction timeline
52 to reflect more of the discrete construction activities that had taken place in between
53 the successive major events for better clarity.

78 3. From Fig. 2, it was indeed noted that further excavation of 1 m uphill of the
79 reinstated slope and behind the installed sheet pile wall did induce additional
80 soil movements as recorded by both the in-pile and in-soil inclinometers
81 located adjacent to the failed slope in Ong et al. (2015).

82 4. The sheet piles were installed on Day 5 and Day 6 at the toe of the failed slope
83 area and its immediate vicinity in an attempt to stabilize the affected area and
84 to minimise further slope movements (see Fig. 2). However, on Day 7 (end of
85 Stage 2), subsequent excavation of 1 m that was carried out uphill and behind
86 the installed sheet pile wall inevitably caused further detrimental soil
87 movements perhaps due to limited mobilization of the remolded shear strength
88 of the failed clay slope in trying to sustain the original slope gradient.

Fig. 2. Sheet piles installed on Days 5 & 6 at toe of the failed slope and subsequently tilted
