## Rock slope stability problems in Gold Coast area, Australia

Shokouhi Ali, Gratchev Ivan, Charrismanagara Arry  
Griffith University – Gold Coast campus - Australia

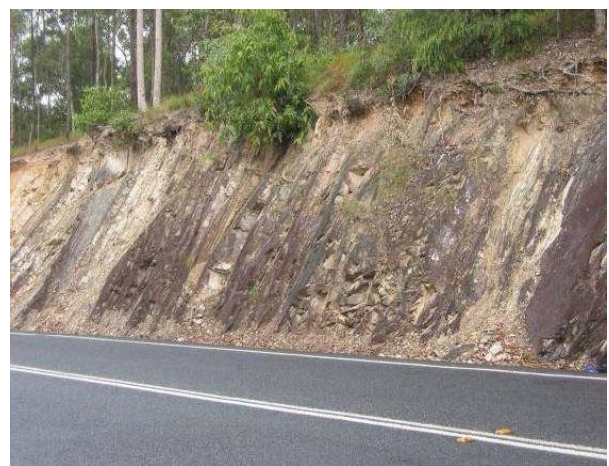
Figure 2 - One of investigated slopes

The investigation field was located along Beaudesert – Nerang Road, immediately south-east of the Beaudesert – Nerang Road / Arunta Drive intersection, on the Gold Coast (Fig.1). The approximate length of the existing cut slope is 200m and with the height of approximately 7m. (Fig.2)

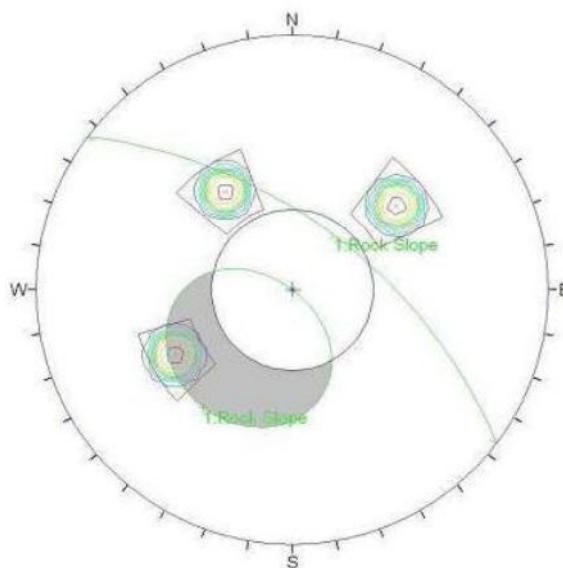
**Figure 3 - Planar sliding of location 1**

The collected data were analyzed by Dips computer software to identify the potential failure modes of the investigated slopes. The results from kinematic analysis indicate that at location 1, there is only one potential failure mode. Planar sliding is the most likely failure mode that may occur at this location (Fig.3). As can be seen in Fig3 some of the discontinuities are located in gray shade that shows the potential planar sliding area. Toppling and wedge failure analyses show, there are no toppling and wedge potential failure at location 1.

The results from SMR analyses consistently show that location 2 has the best rock mass condition out of the three locations, followed by location 1, and location 3 has the worst. These results reflect the evidence that there was a significant recent rock fall at location 3. At location 1, the rock fall was deemed to be minor, however, small fragments of rock blocks were found along the toe of the rock slope.
