**A case study of a corroded cast iron water main on Bridge Rd,
Richmond**

A CASE STUDY OF A CORRODED CAST IRON WATER MAIN ON BRIDGE RD, RICHMOND

A.J Spark^{1,2}, D O’Keefe³, I Cole¹, A.M Osborn², D Law² & L.P Ward²

CSIRO¹, Melbourne, Australia, RMIT University², Melbourne, Australia & City West Water³, Melbourne, Australia

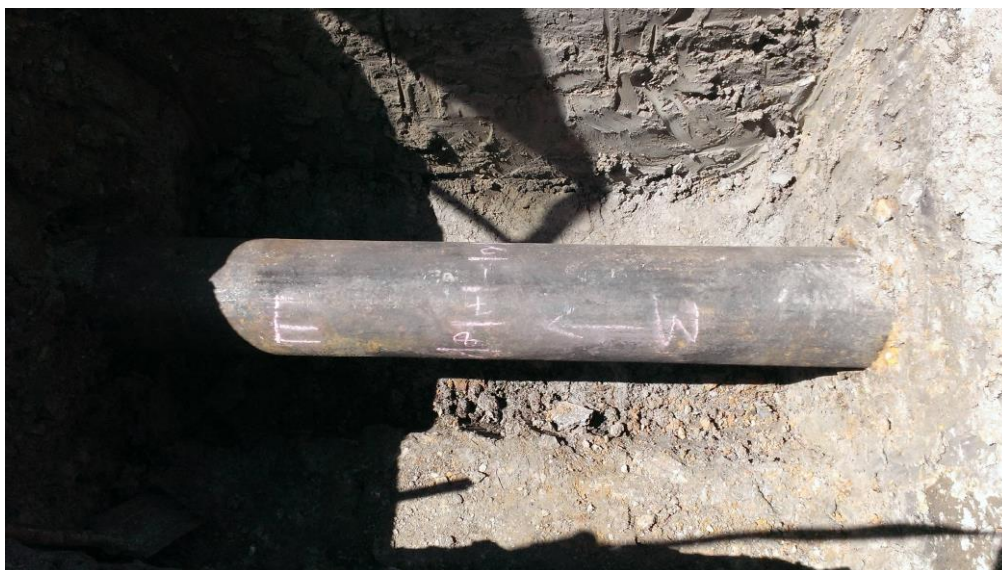
Figure 1: Photo of excavated pipe

Visual inspection showed the pipe to be in good condition, especially for its age, with some faint regions of orange corrosion product present on the external surface. As the pipe had been wiped down prior to the inspection to remove all remnant of soil, it is possible that more obvious signs of corrosion had been removed.

Considering the age of the main, there were no visual signs of weeping or leaks discovered during the excavation. There was however, evidence of localised corrosion in the form of regions of corrosion product on the external surface. A precursor ultrasonic scan at key intervals including the crown of the pipe identified major pits, albeit not through wall corrosion.

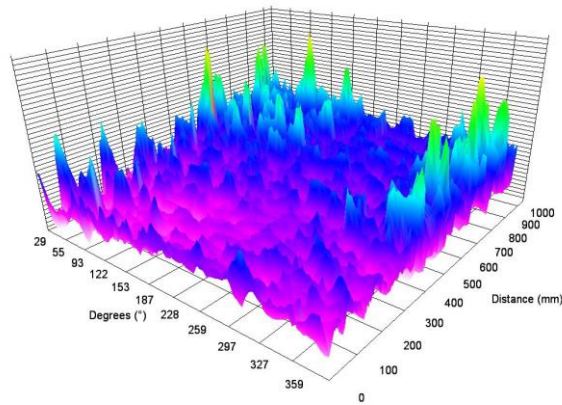
Figure 2: MFL Scan Plot

Results from the MFL scan (Figure 2) show significant pitting corrosion has occurred across certain regions of the pipe section investigated. The most severe pitting all occurs within a 100° quadrant across the pipes circumference as shown in Figure 3 which corresponds with the crown of the pipe, road side. The ten worst defects recorded (Table 2) are all through wall corrosion defects. Axial location refers to distance along the pipe of the one metre section scanned. Orientation refers to position around the pipe with 0° being the top of the pipe.

The report identified the ten worst defects along the pipe interface all of which were through wall pits. Many of these defects were concentrated on the crown of the pipe along the 1m length, with the only one not on the crown of the pipe being located at 93°. The disparity in defect size detected between the precursor ultrasonic scan and the MFI scan suggests a limitation in one or both techniques and that multiple techniques should be used to get an accurate understanding of the condition of an asset. The finding that all ten of the worse defects in the pipe are on the top half of the pipe and that the bottom of the pipe is relatively free of significant pitting suggests that there has been water flow on the bottom of the pipe (16, 17). Due to compaction of the soil directly below a pipeline, the bottom of a pipe is an area where water will collect as it struggles to flow further down, especially after heavy rain fall. This would reduce the oxygen concentration along the bottom of the pipe and also decrease the number of triple phase boundaries along this section of the pipe leading to a decrease in corrosion rate (3). While there was no visual evidence of this during the site inspection, the pipe was excavated below the level of the pipe so this may have been missed. The soil above the pipe where the worst defects are clustered would be the least compacted, so that this area would have the most porous structure allowing water to flow freely through the soil, leading to oxygen levels being readily replenished (18). This would increase the corrosion rate on the crown of the pipe.

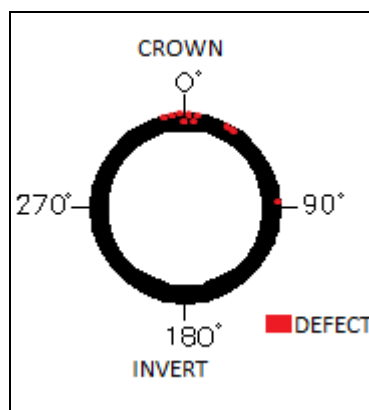
Figure 3: Cross Sectional Area of Pipe Defect

The pipeline under investigation has been in functional operation for 150 years so some corrosion is expected. At this stage in the pipe's life it is still in good condition over the bulk of the surface examined, with only the crown of the pipe experiencing major pitting. The pits at the crown of the pipe have penetrated the surface of the pipe, but yet there was no visible water loss. Taking into consideration the soil environment surrounding the pipe, pitting is expected though pits would be expected along the sides of the pipe as well as the crown. There were no chemically corrosive substances detected in the soil in sufficient

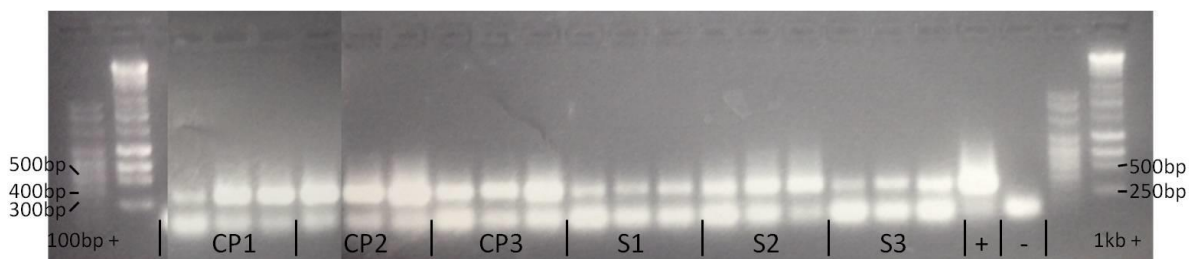
Each of the amplicon solutions were verified by gel electrophoresis. When matched against sizing ladders (HyperLadder 1kb plus and HyperLadder 100bp plus) the amplified DNA were shown to be in the range of 300bp, as expected. There was also no contamination of the amplification process. This indicates DNA was successfully extracted from both the soil samples and, more uniquely, the corrosion product scrapings.

Figure 4: Image of gel electrophoresis results showing consistently sized amplicons and no contamination
