Deterioration of flood affected Queensland roads – An investigative study

Masuda Sultana^{a,*}, Gary Chai^b, Sanaul Chowdhury^b, Tim Martin^c

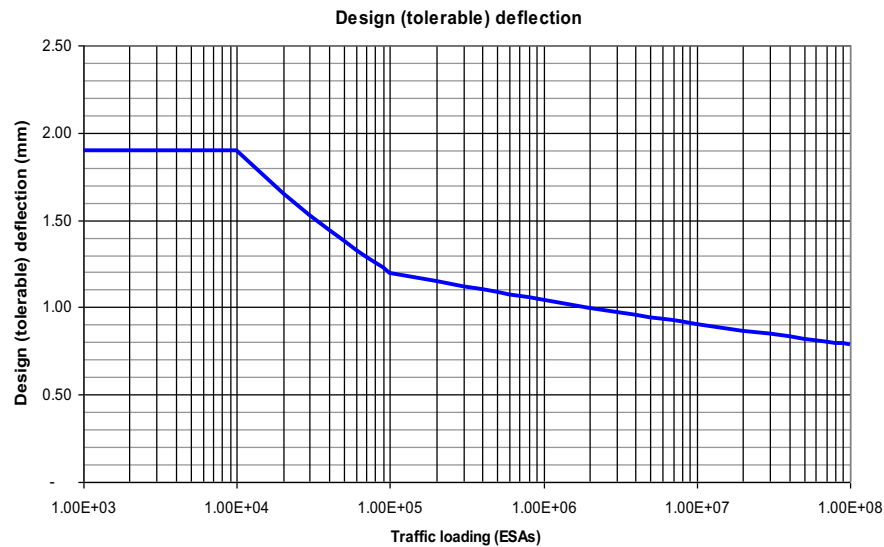
Fig. 1. Tolerable deflection on Council roads [24].

For Lightly trafficked roads, the tolerable deflection chart from Council's "Pavement Rehabilitation Design Manual" [21] was used to estimate remaining life (refer to Fig. 1). The loading in terms of ESA's was converted to years based on the traffic loading. The BCC Pavement Rehabilitation Design Guide [22] applied design tolerable deflection, $D_{tol} = 2.1$ mm for traffic loading up to

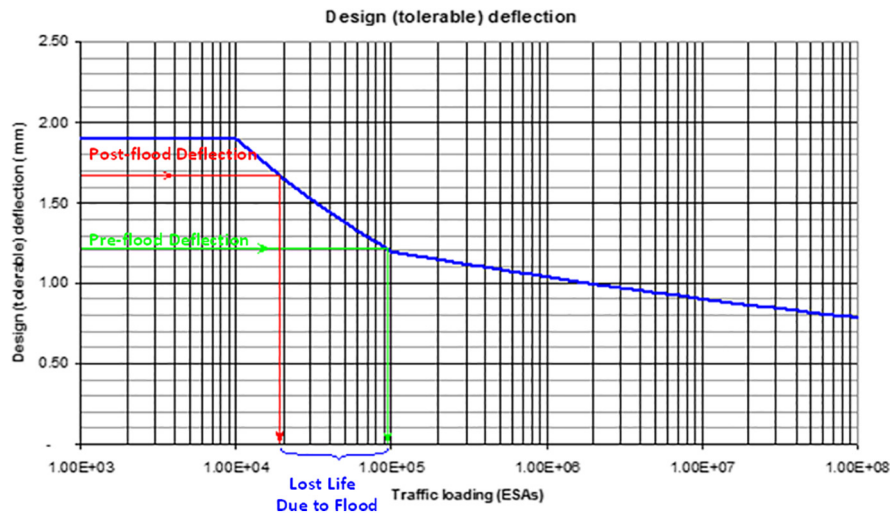
Fig. 2. Park Drive, Graceville – Effect of flooding on pavement life [12].

The principal failure criteria considered to estimate remaining life was subgrade rutting using the design methodologies appropriate to the traffic loading level. Based on the traffic loadings, time to reach this loading was determined. For Heavily trafficked roads, the Department of Main Roads [20] tolerable deflection chart (refer to Fig. 1) was used to estimate remaining life in terms of Equivalent Standard Axles (ESAs). The overlay design chart for tolerable deflections follows Nomograph in Fig. 2 [7].

3.7×10^4 , and $D_{tol} = 1.6$ mm for traffic loading up to 1.5×10^5 . These values were derived from field investigation, and based on the assumption, that ‘a representative rebound deflection value is the mean of adjusted measured rebound deflections plus two standard deviation [21]. An example is shown in Fig. 2 where for Sherwood Road (Sherwood), Brisbane before the flooding, rutting of the subgrade did not control the life of the pavement. Whereas, post-flooding, rutting of the subgrade is estimated to occur in less than 4 years [7].

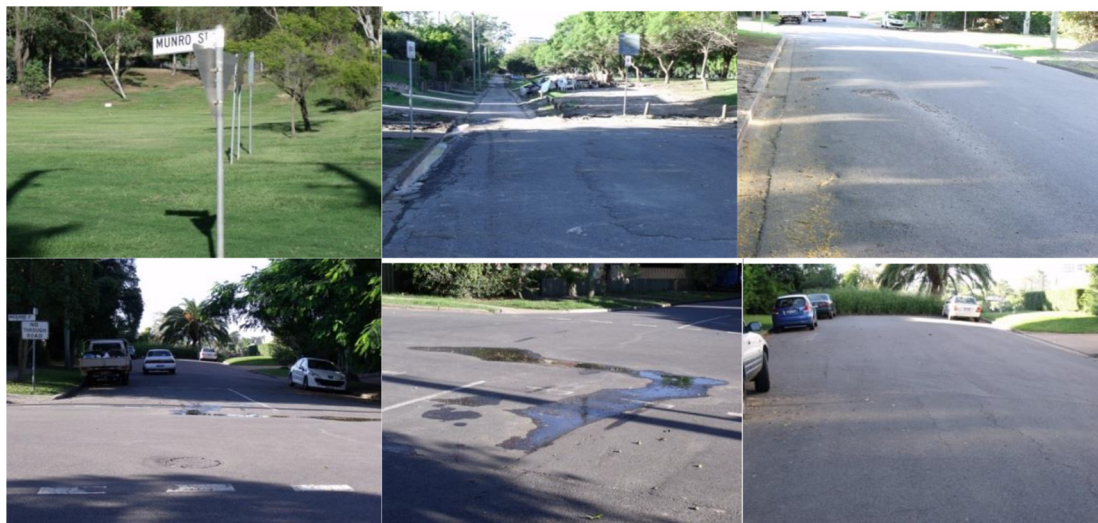
Fig. 4. Loss of surface condition after flood in Munro St, Brisbane (Photo Courtesy: BCC [32]).

Increases in surface condition distress were observed in many pavement sections following the January 2011 flooding. The photographs in Fig. 4 [32] indicate that deterioration of the surface condition were visible after the January 2011 flood in Munro Street, Brisbane [32]. The photographs in Fig. 5 indicate that there were rapid increases

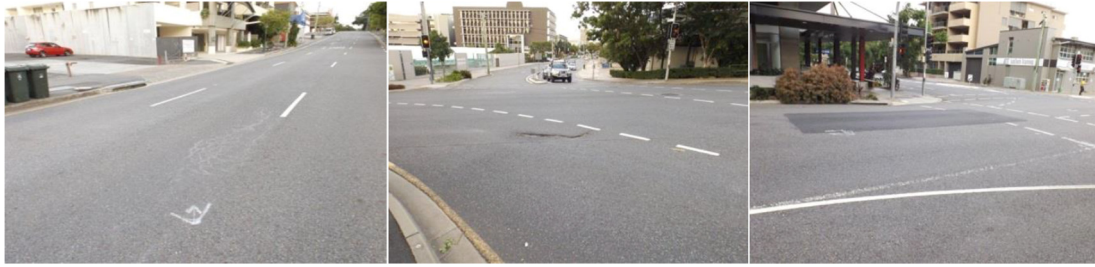
Fig. 5. Images shows deterioration of surface condition and pavement repair of flood affected parts of Cordelia Street, South Brisbane (pictures taken in 2015).

in surface condition distress of Cordelia Street, South Brisbane following the same flood.

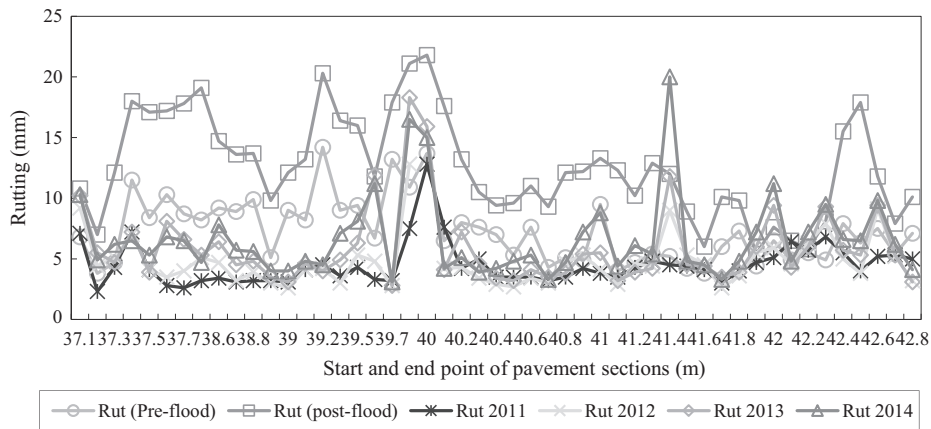
Fig. 6. Rutting plot for rehabilitated sections of Rockhampton – Emu Park Road, Livingstone Shire Council, Central Queensland.

The rutting and roughness data from the year 2009 to 2014 of the 47 flood affected sections of the Rockhampton Emu Park Road in the Livingstone Shire Council, Central Queensland, have been plotted in Figs. 6 and 7. There were significant increases in rutting values in 45 pavement sections after the 2010 flooding event. Roughness values were also increased in a number of pavement sections of the Rockhampton Emu Park Road.

The rehabilitation work on the Rockhampton-Emu Park Road was completed in November 2011. As a result of the rehabilitation, the rutting and roughness data, collected from 2011 to 2014, shows significant improvement. However, very few sections again deteriorated in 2013 and 2014. The heavy rainfall event (nearly 300 millimetres of rain) in parts of the Capricorn Coast, from the morning of 25 March to 26 March, 2014, flooded around 50 roads in the Rockhampton, Livingstone and Gladstone Council areas [33]. The monthly rainfall data, (refer to Table 3) also

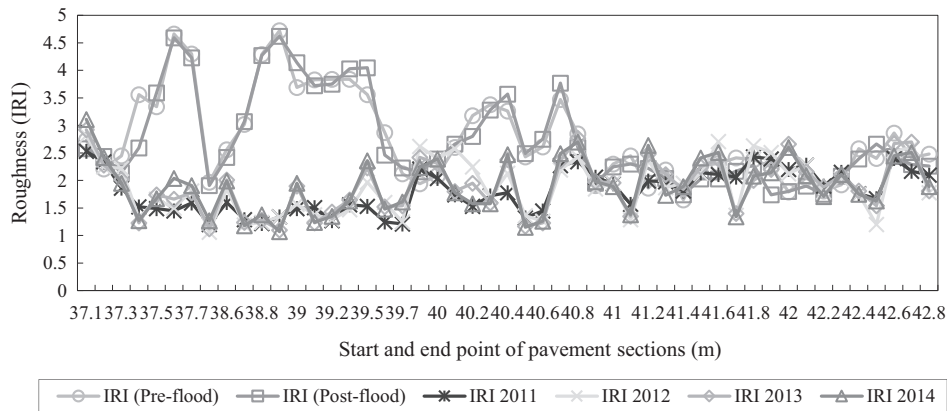
Fig. 7. Roughness plot for selected sections of Rockhampton-Emu Park Road, Livingstone Shire Council, Central Queensland.

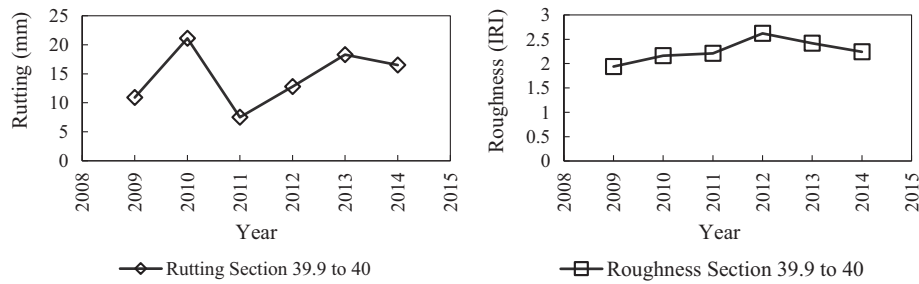
Fig. 8. Loss of Rutting and roughness in a section of Rockhampton-Emu Park Road, Livingstone Shire Council, Central Queensland.

confirm that there was heavy rainfall in the area in January and March 2013 and February and March 2014, which may be one of the possible causes of increasing rutting values in some sections of the road. Therefore, the deterioration of some sections could be initiated by the heavy rainfall and flooding events in 2013 and 2014. Three sections were identified as critical sections for the analysis: the data for roughness and rutting have been plotted in Figs. 8–10. The rate of increase and decrease in the rutting and roughness values of three critical sections is shown in Table 5.

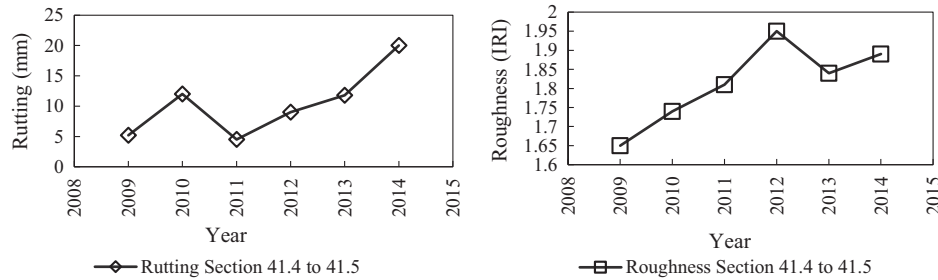
Fig. 9. Loss of Rutting and roughness in a section (Section ID 41.4 to 41.5) of Rockhampton-Emu Park Road, Livingstone Shire Council, Central Queensland.

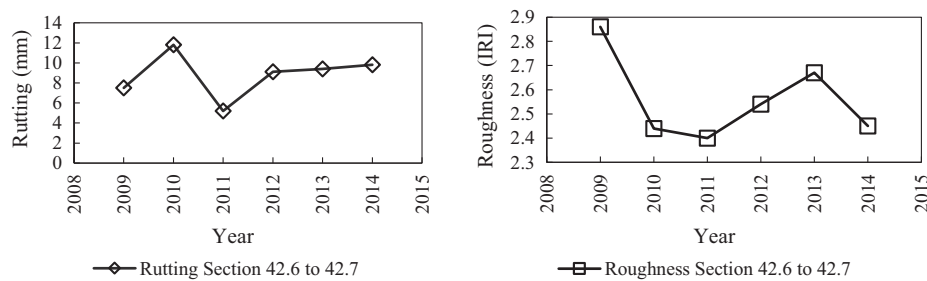
Fig. 10. Loss of Rutting and roughness in a section (Section ID 42.6 to 42.7) of Rockhampton-Emu Park Road, Livingstone Shire Council, Central Queensland.

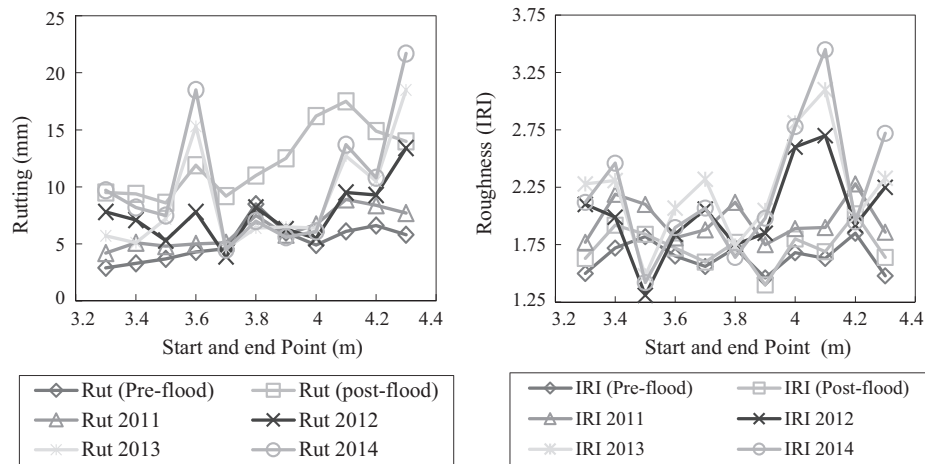
Fig. 11. Rutting and roughness plot for flood affected sections of Western Yeppoon-Emu Park Road, Livingstone Shire Council, Central Queensland.

The data for rutting and roughness from the year 2009 to 2014, for the selected flood affected sections (17 sections) of the Western Yeppoon-Emu Park Road in Livingstone Shire Council, Central Queensland have been plotted in Figs. 11 and 12. The rehabilitation works of these sections were completed in October 2011. There was an increase in the rutting values in 2010. Although, the rutting values in 2011, 2012 and 2013, shows some improvement, there was an increase in the roughness values in some sections in 2013 and 2014.

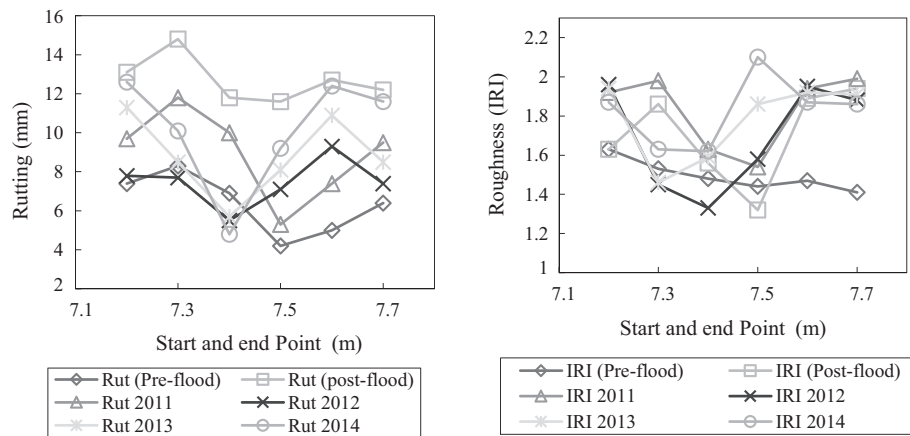
Fig. 12. Rutting and roughness plot for flood affected sections of Western Yeppoon-Emu Park Road, Livingstone Shire Council, Central Queensland.

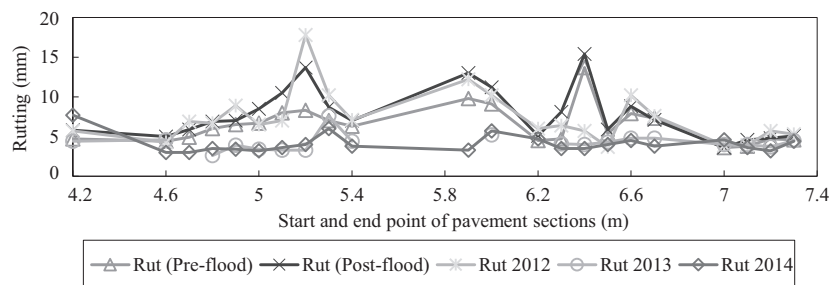
Fig. 13. Rutting plot for flood affected sections of Rosewood-Marburg Road in Ipswich City Council.

The data for the rutting and roughness for flood affected sections of the Rosewood-Marburg Road, Ipswich City Council have been plotted in Figs. 13 and 14. This road was flooded during the January 2011 flood. The rehabilitation of this road was completed in November 2012. While there were increases in the rutting values in 2011 and roughness values in 2011 and 2012, the rutting and roughness values decreased after the rehabilitation in 2012.

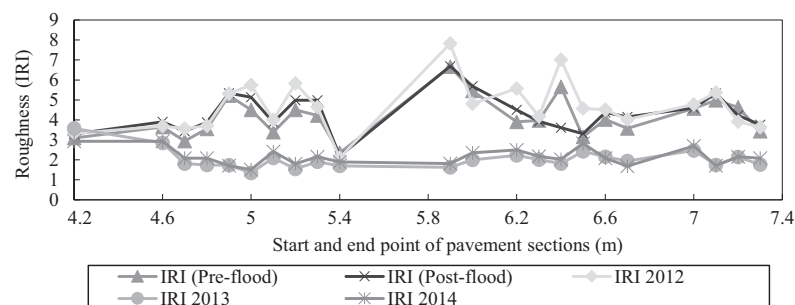
Fig. 14. Roughness plot for flood affected sections of Rosewood-Marburg Road in Ipswich City Council.
