## **Assessment and Modelling Deterioration of Flood Affected Pavements**

# **ASSESSMENT AND MODELLING DETERIORATION OF FLOOD AFFECTED PAVEMENTS**

A thesis Submitted in fulfilment of the requirements of the degree of

Griffith School of Engineering, Gold Coast Campus

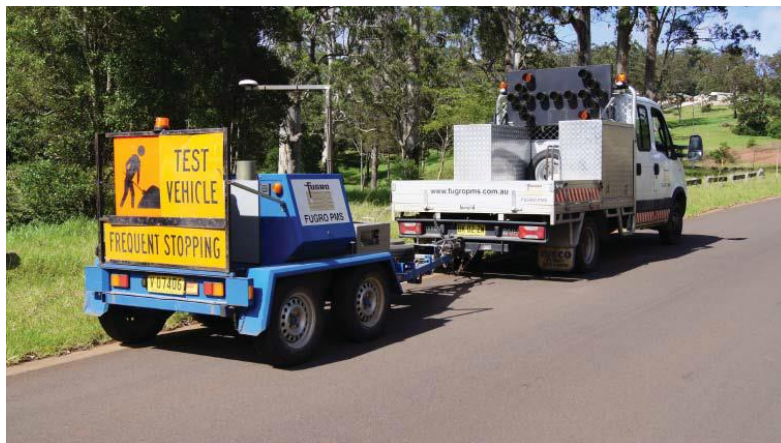
Figure 2.3: Using FWD for pavement strength testing in the outer wheel path (Fugro 2012)

Figure 2.2 represents the generalised deflection bowl of a falling weight deflectometer testing (BCC 2011), while Figure 2.3 shows the use of FWD for pavement strength testing in the outer wheel path, in order to estimate structural capacity for the purposes of overlay design (Fugro 2012).

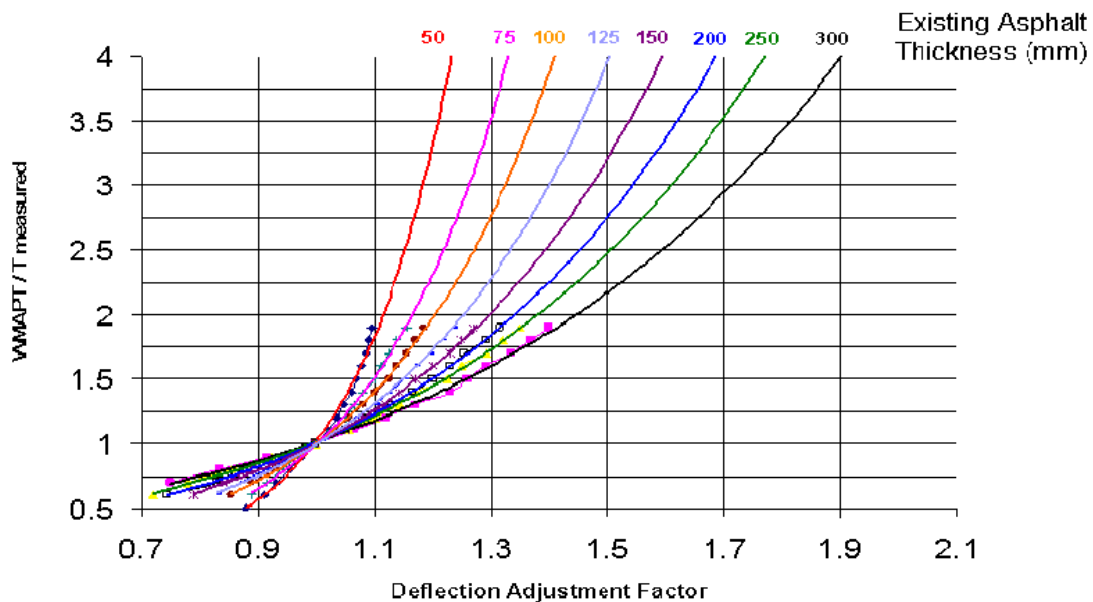
Deflection and back analysis results must be corrected to the average working temperature of the pavement for a particular location. This average working temperature is referred to as the Weighted Mean Annual Pavement Temperature (WMAPT) (TMR 2012). For design expediency, WMAPT zones have been derived for the state as given in Chapter 2, page 2-47 of the Pavement Rehabilitation Manual (TMR 2012). Temperature correction for Benkelman Beam and normalised 40 kN FWD deflections results for a pavement with a thin asphalt surfacing or seal is shown in Figure 2.4. For Brisbane, WMAPT ranges from 29° to 32° Celsius (TMR 2012).

Figure 2.4: Temperature correction for Benkelman Beam and normalised 40kN FWD deflections results for a pavement with a thin asphalt surfacing or seal (TMR 2012)

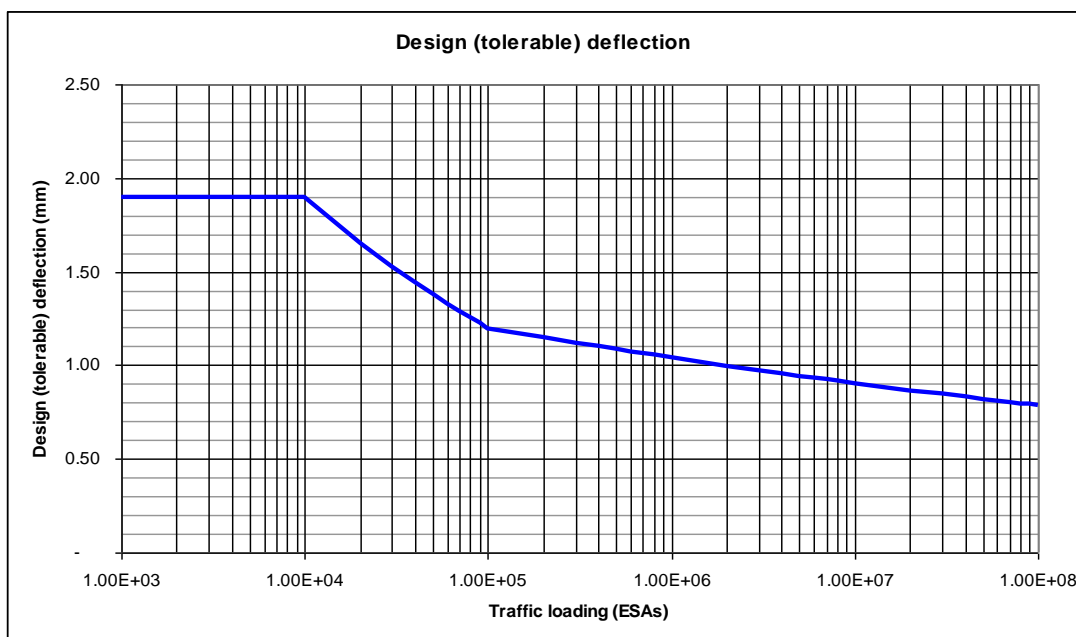
by BCC is based on the Department of Main Roads (2007) approach. For heavily trafficked roads, the Department of Main Roads (2007) tolerable deflection chart (refer to Figure 3.2) (DMR 2007) was used to estimate remaining life in terms of ESAs. The overlay design chart for tolerable deflections follows Nomograph in Figure 3.2 (BCC 2011). The background and history of earlier pavement design practices and manuals are summarised in Nomograph. The TMR CBR 3% design curve is used for traffic loading  $ESA > 1 \times 10^5$ . In traffic loading between  $1 \times 10^4$  and  $1 \times 10^5$  ESA, the tolerable deflections were adjusted to provide a smooth and continuous criterion (Nomograph). For traffic loading  $ESA < 1.0 \times 10^5$ , caution should be exercised in applying the design chart provided in Nomograph since these values have not been fully validated to date (BCC 2011).

Figure 3.2: Nomograph for tolerable deflection on Council roads (BCC 2011)

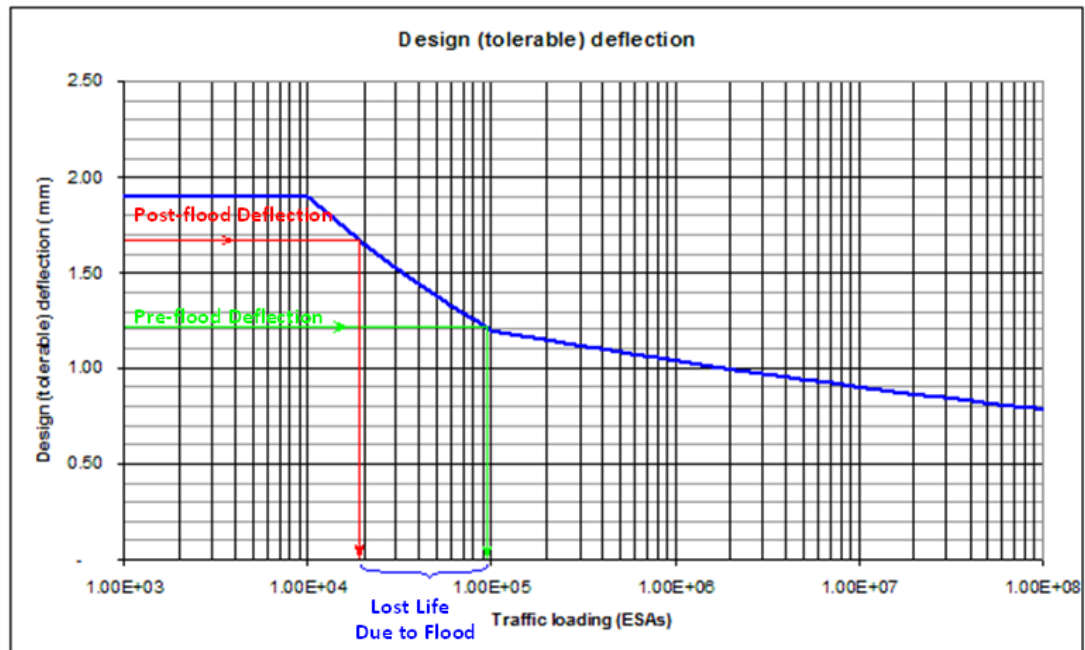
An example is shown in Figure 3.3 for Park Drive, Graceville where before the flooding rutting of the subgrade did not control the life of the pavement. Post-flooding, rutting of the subgrade is estimated to occur in less than four years (Condric and Stephenson 2013).

Figure 3.3: Park Drive, Graceville – effect of flooding on pavement life (Condric and Stephenson 2013)

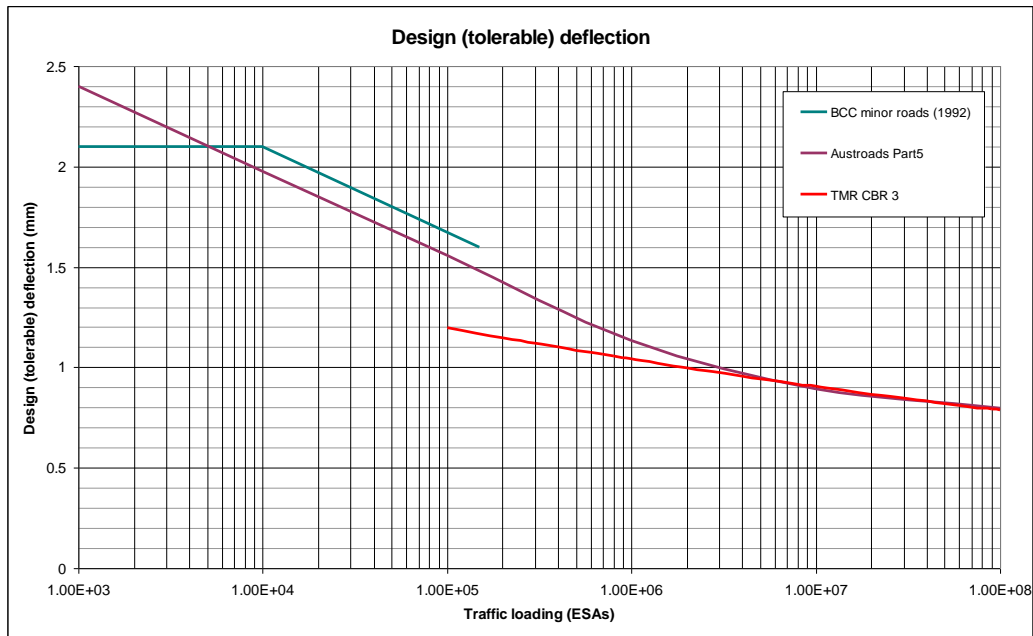
The 1993 BCC Pavement Rehabilitation Design Guide (BCC 1993) applied Design tolerable Deflection,  $D_{tol} = 2.1$  mm for traffic loading up to  $3.7 \times 10^4$ , and  $D_{tol} = 1.6$  mm for traffic loading up to  $1.5 \times 10^5$ . These values were derived from field investigation, and based on the assumption, that ‘a representative rebound deflection value is the mean of adjusted measured rebound deflections plus two standard deviations’. Accepting that the coefficient of variation (CV) was 0.5 in these calculations, 0.2 mm tolerable deflection reduction can be applied if the representative deflection will be calculated as the mean deflection plus 1.64 standard deviation ( $\bar{x} + 1.64s$ ). This adjustment is necessary since the tolerable deflection for traffic loading of  $ESA < 1.0 \times 10^5$  was considered by City Design as being too high. Tolerable deflection values used in the last four decades are summarized in Figure 3.4 - BCC Tolerable Deflection Curves (1993 to 2010) (BCC 2011).

Figure 3.4: BCC Tolerable Deflection Curves (1993-2010) (BCC 2011)

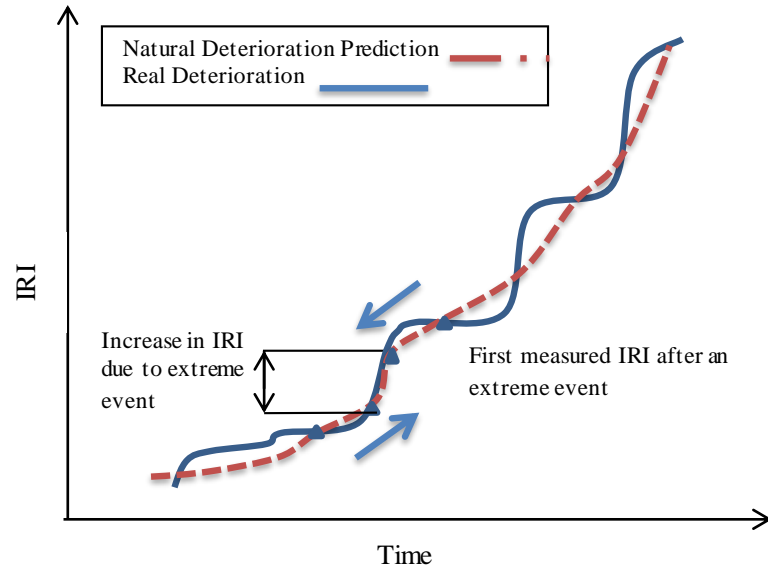
Second, the effect of extreme events on road deterioration was quantified by forward-projecting IRI values from one measured IRI to the point where the event occurred. Consequently, they backward projected the next measured IRI to the point where the event occurred; the difference between these two values is due to the extreme event that happened in that month if no other events/maintenance activities had taken place in that period. This is illustrated in Figure 3.6. To fit a model to these quantities, they had to first collect the data needed (Shamsabadi et al. 2014).

Figure 3.6: Quantifying the increase in IRI due to extreme events (Shamsabadi et al. 2014)

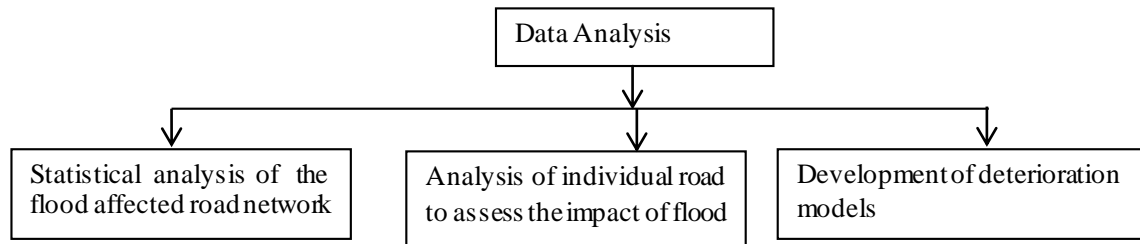
history were collected for the assessment and development of modelling for the deterioration of the structural and surface condition (rutting and roughness) of flood affected pavements. Figure 4.1 shows the general methodology of the data analysis.

Figure 4.1: Summary schematic of data collection and analysis

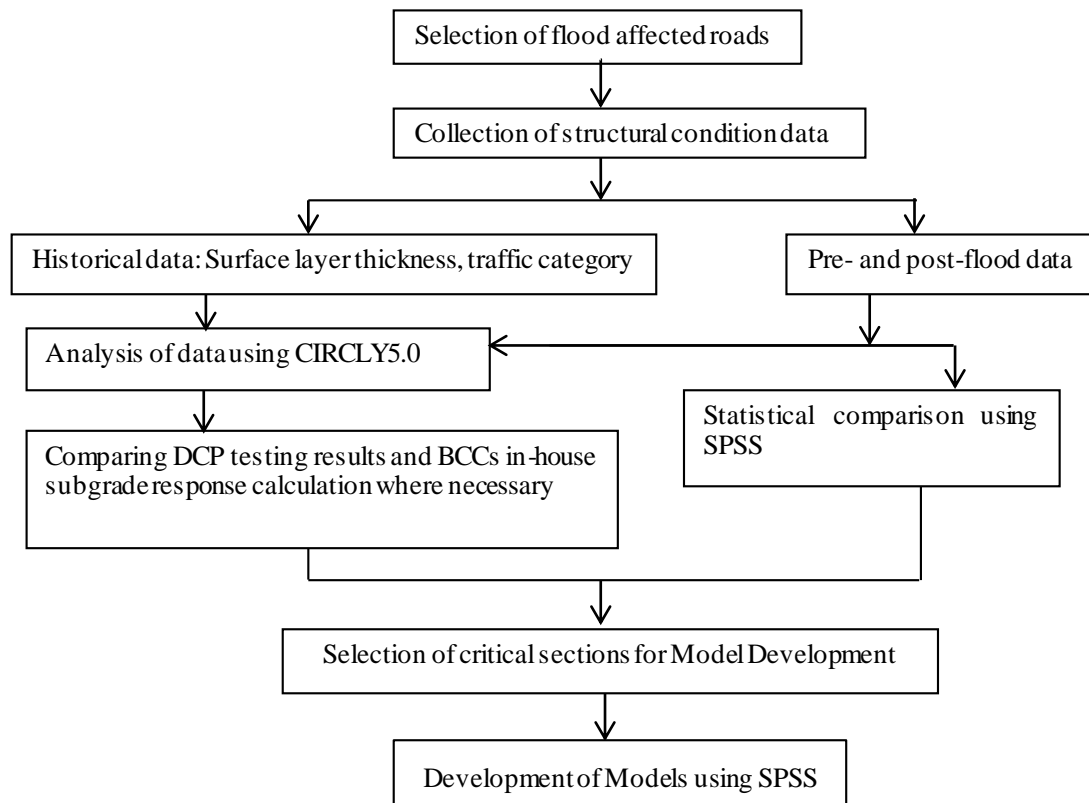
The organisation and analysis techniques of structural condition data is shown in Figure 4.2. The organisation and analysis techniques of rutting and roughness data is shown in Figure 4.3. MS Excel was used to plot data and SPSS was used for analysis, comparison of data and to develop the models.

Figure 4.2: Summary schematic of structural condition data collection, analysis and development of deterioration model

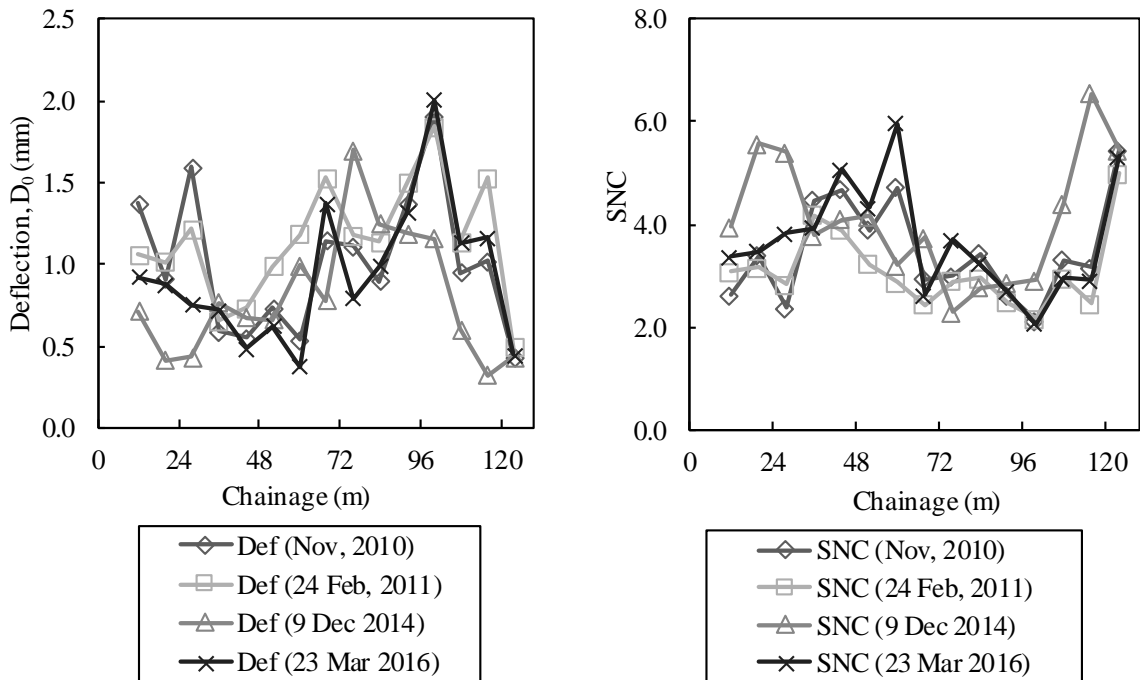
Figure 5.5: Maximum deflection vs chainage and modified structural number vs chainage of outer wheel path (2R) (Luxford Street, Chelmer)

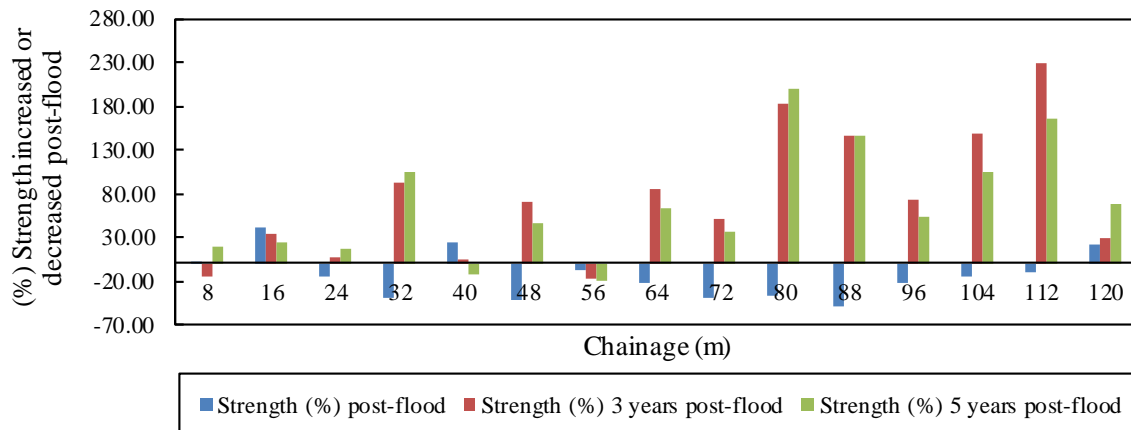
The street was rehabilitated on 26 May 2011. The percentage increase or decrease in strength immediately after flooding, three years post-flooding and five years post-flooding are shown in Figures 5.6 to 5.9. Positive signs refer to an increase and negative signs refer to a decrease in strength. These figures indicate that the pavement regained strength from 10% to 100%.

Figure 5.6: Comparison of structural strength post-flooding (outer wheel path [1L]) in Luxford Street, Chelmer

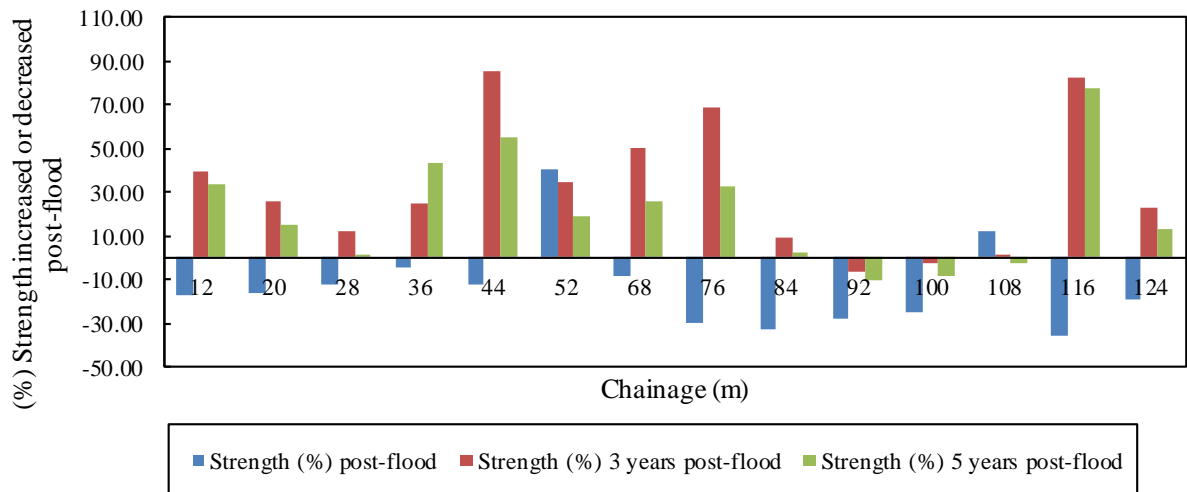
Figure 5.7: Comparison of structural strength post-flooding (inner wheel path [1R]) in Luxford Street, Chelmer

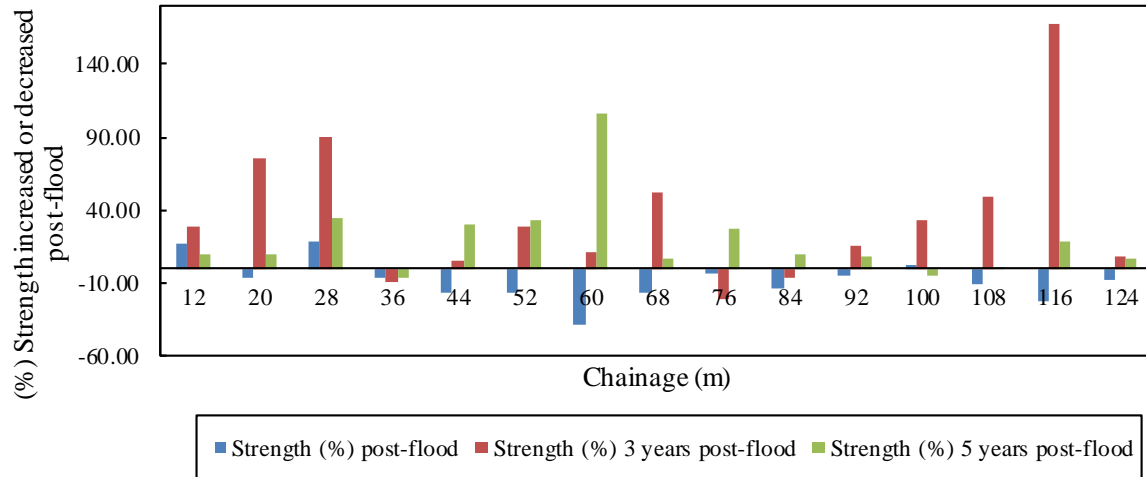
Figure 5.8: Comparison of structural strength post-flooding (outer wheel path [2R]) in Luxford Street, Chelmer

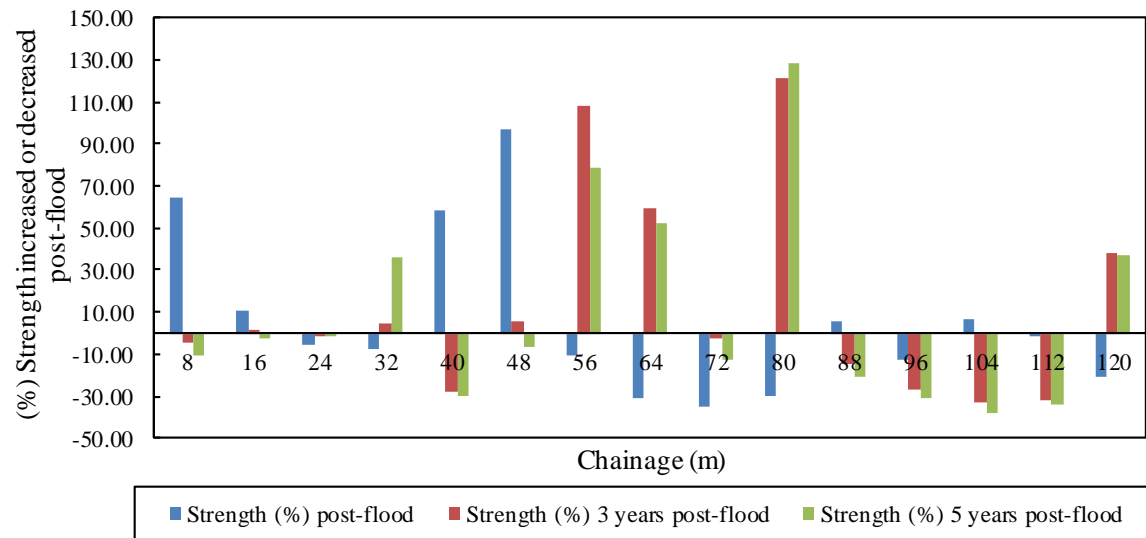
Figure 5.9: Comparison of structural strength post-flooding (inner wheel path [2L]) in Luxford Street, Chelmer

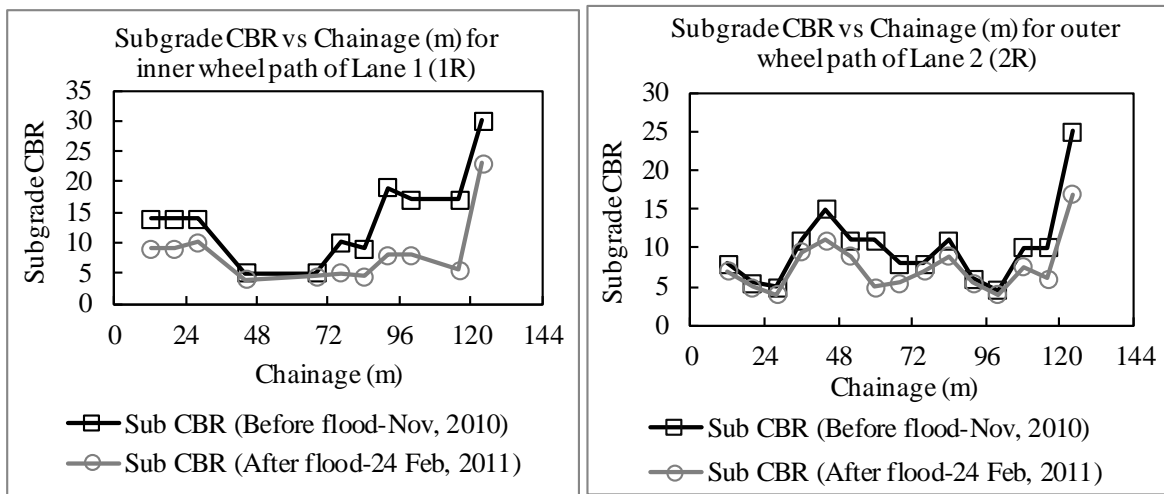
chainages. At some chainages, there were big decreases in CBR (California Bearing Ratio) values.

Figure 5.10: Deterioration curves for subgrade response in Luxford Street, Chelmer

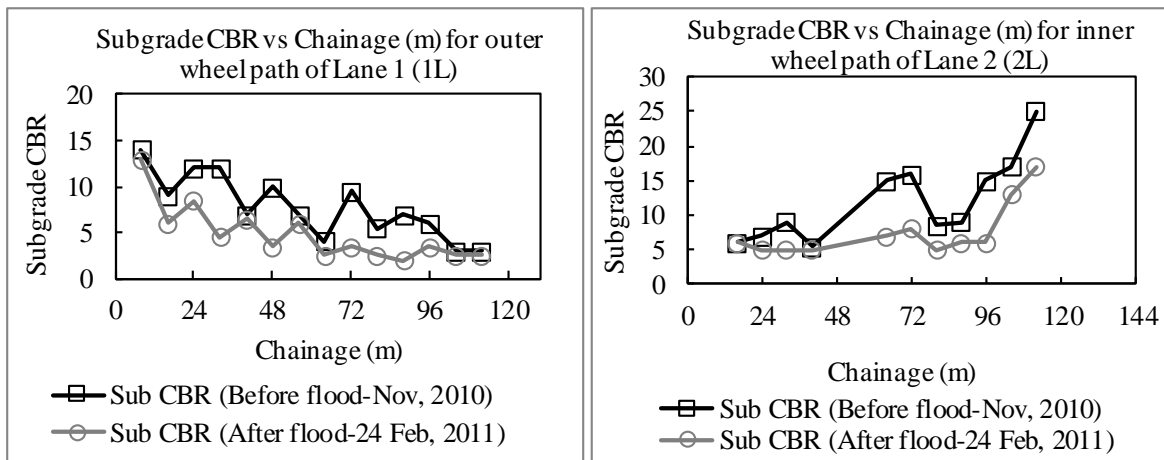
Figure 5.11: Deterioration curves for subgrade response in Luxford Street, Chelmer (inner and outer wheelpath of Lane 1 and 2)

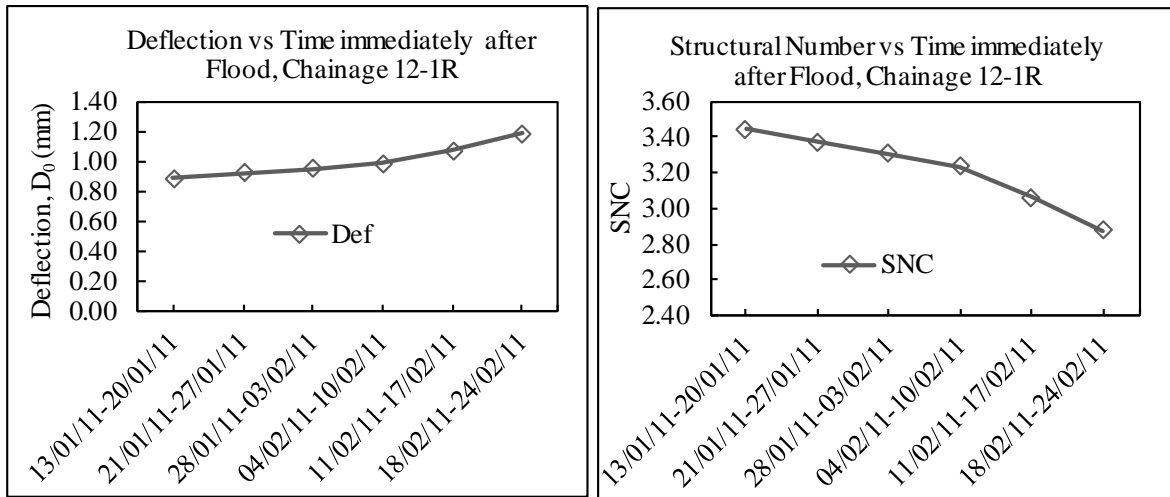
Deflection versus time and SNC versus time graphs are shown in Figures 5.13 to 5.15. There were significant increases in deflection value and decreases in SNC values within six weeks of the flood. These deflection values and reductions in SNC values would not have been so high over such a short period of time if the road were to deteriorate under normal weather conditions without the flooding event. The decrease in pavement strength after the flood could lead to a reduction in the service life of the pavement sections if no rehabilitation measures or repairs were undertaken.

Figure 5.13: Deflection vs time and SNC vs time for Luxford Street, Chelmer, Chainage 12

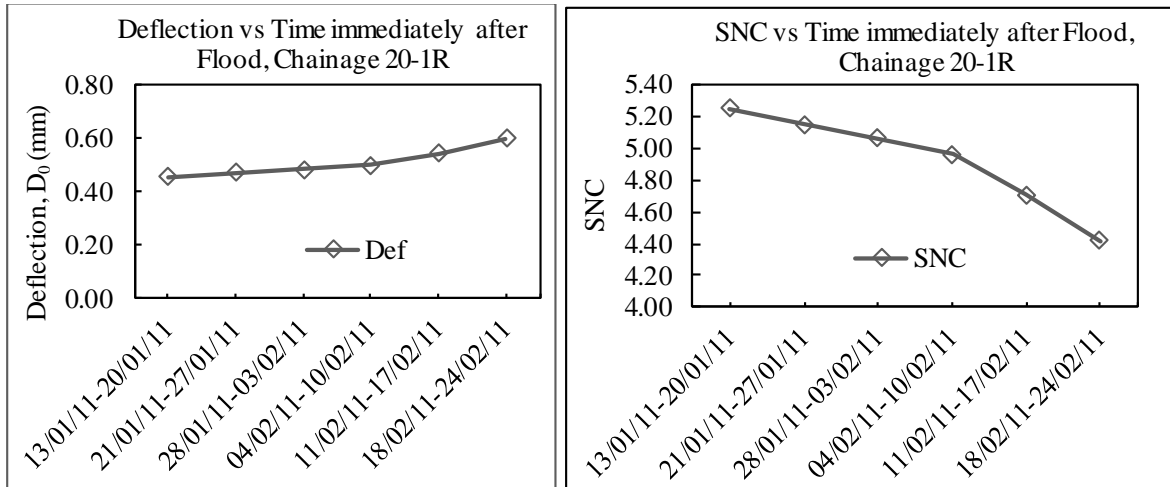
Figure 5.14: Deflection vs time and SNC vs time for Luxford Street, Chelmer, Chainage 20

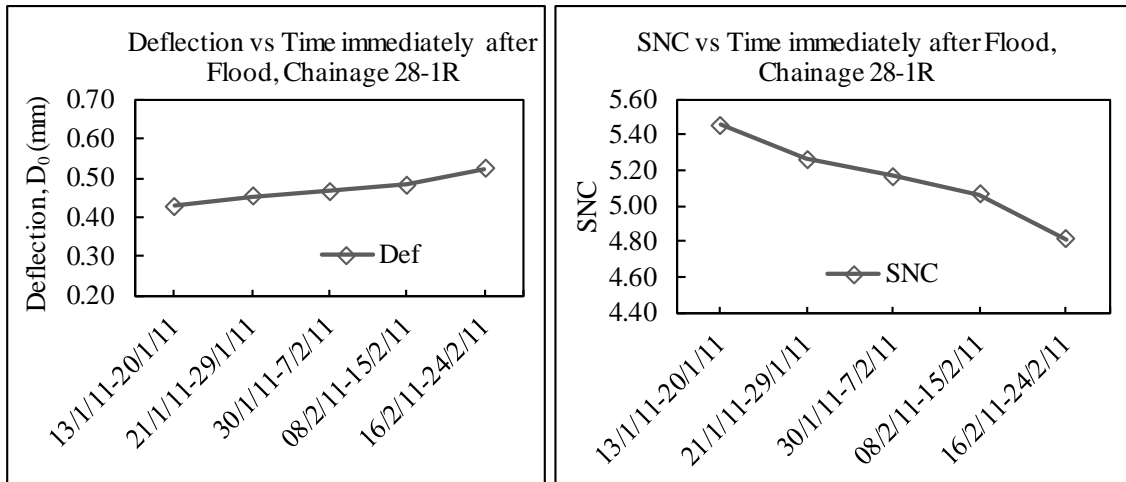
Figure 5.15: Deflection vs time and SNC vs time for Luxford Street, Chelmer, Chainage 28

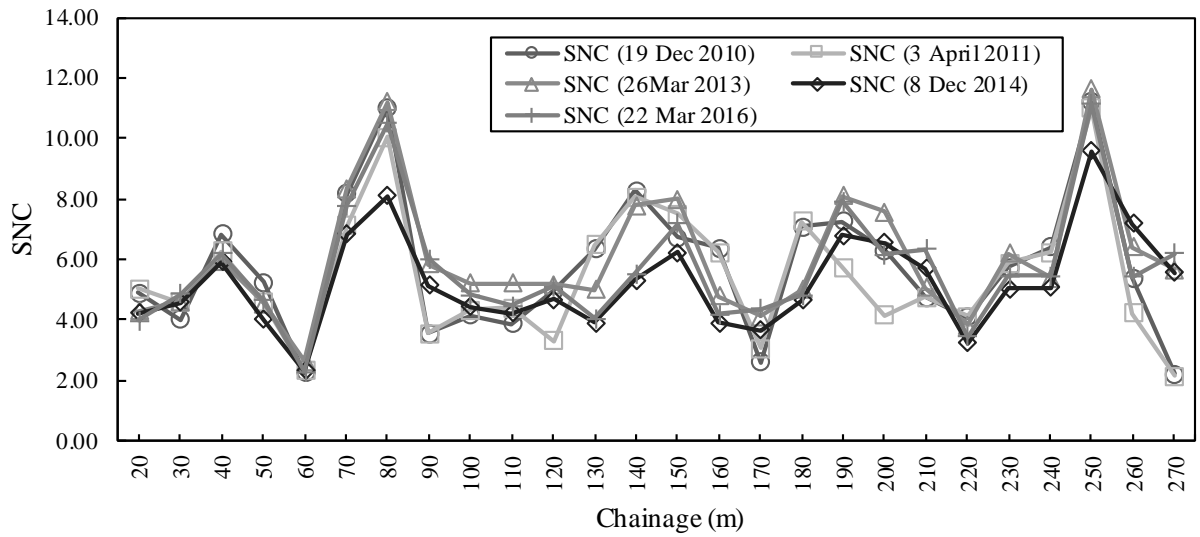
Figure 5.17: Modified structural number vs chainage (outer wheel path [1L]) of Haig Road, Milton

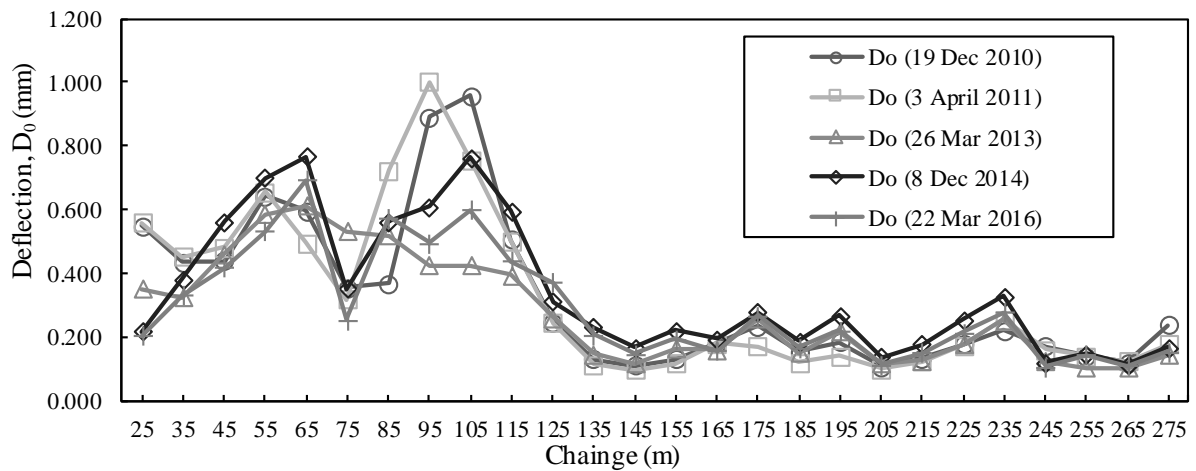
Figure 5.18: Maximum deflection vs chainage (inner wheel path [1R]) of Haig Road, Milton

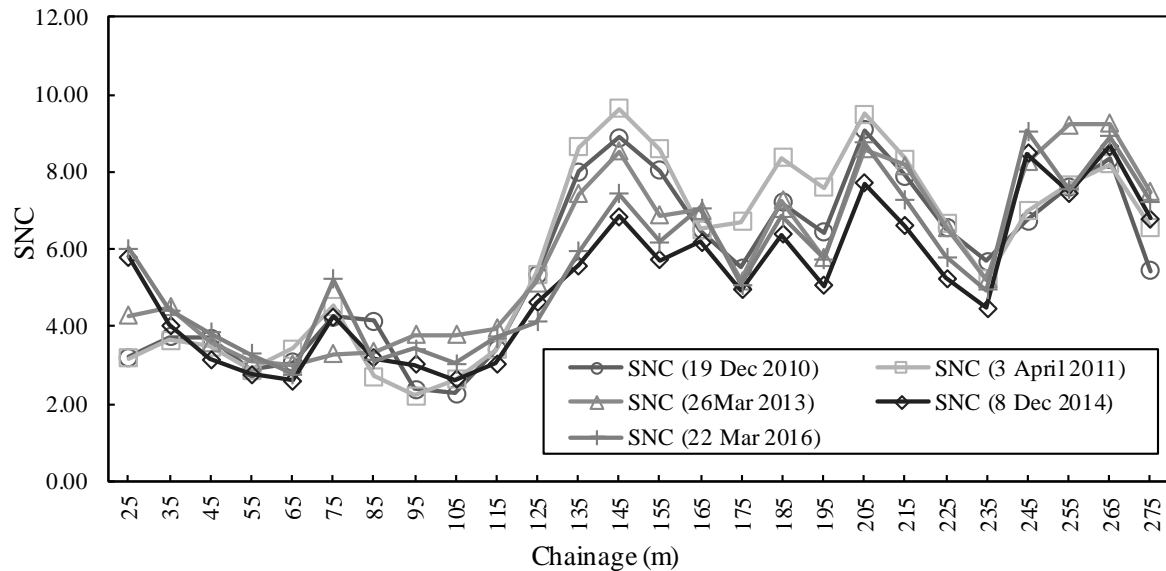
Figure 5.19: Modified structural number vs chainage (inner wheel path [1R]) of Haig Road, Milton

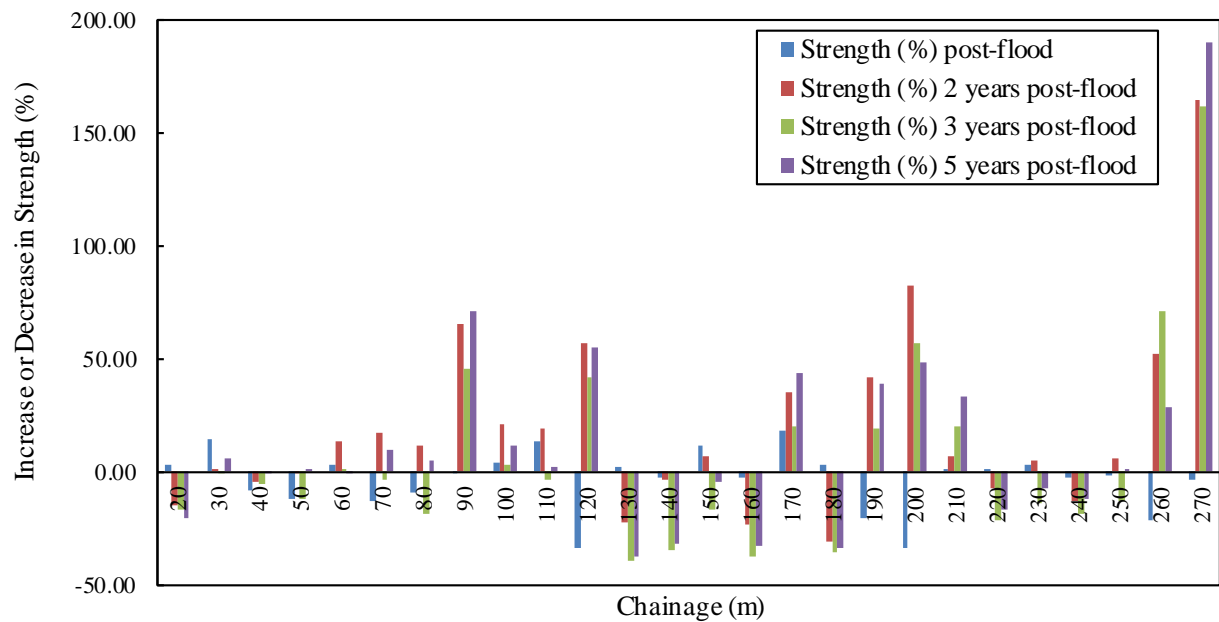
sections started to decrease in strength again. Thirteen testing points gained strength 5 years after flood.

Figure 5.20: Comparison of structural strength post flood (outer wheel path [1L]) in Haig road, Milton

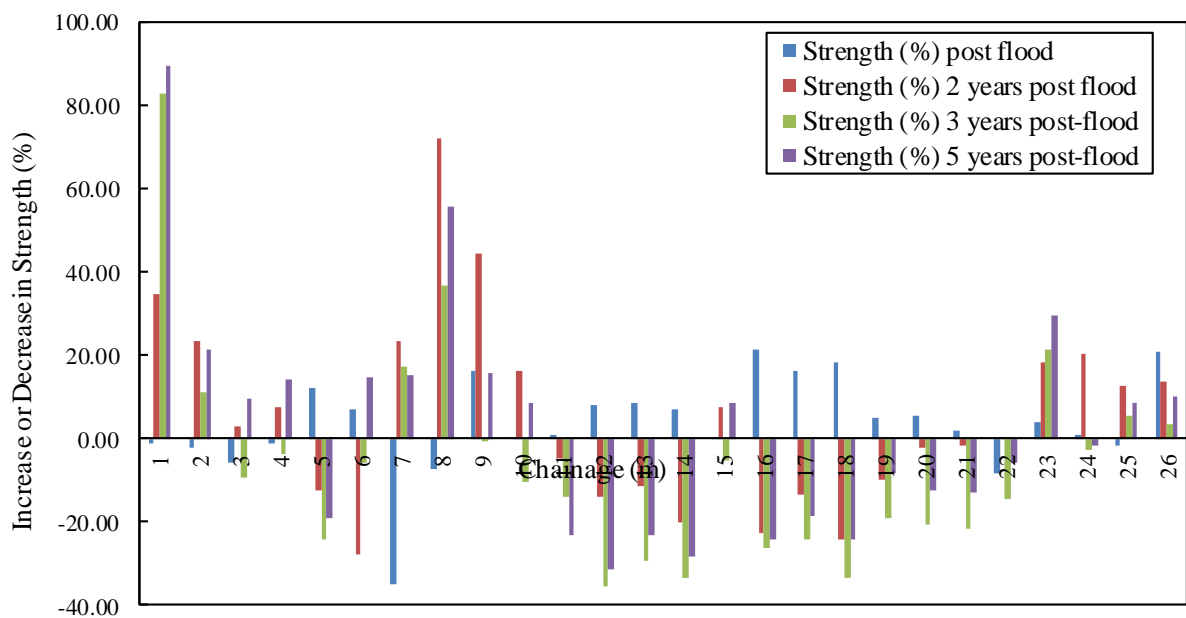
Figure 5.21: Comparison of structural strength post flood (inner wheel path [1R]) in Haig road, Milton

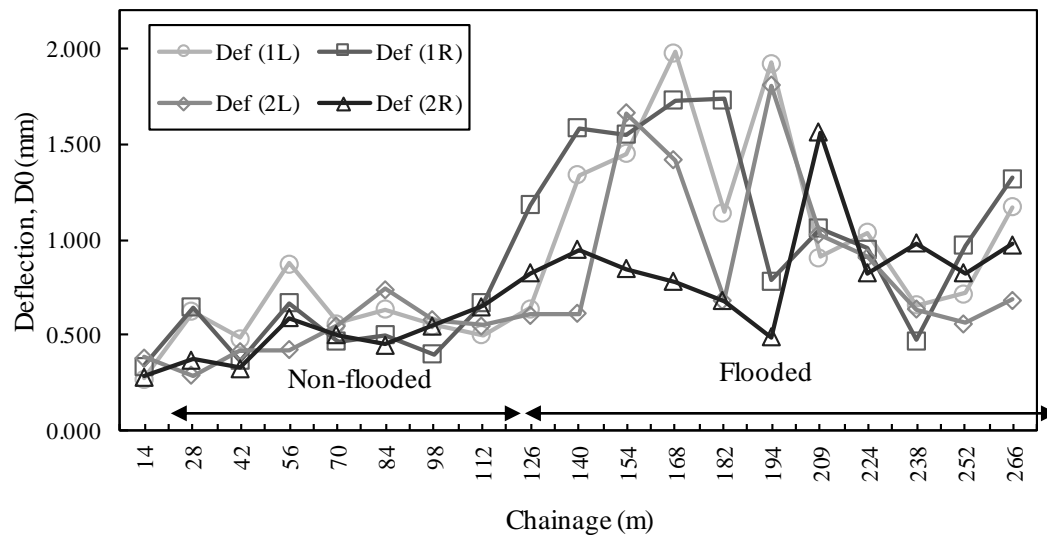
In Sutton Street, chainage 0 m to 120 m was non-flood affected and chainage 120 m to 270 m was flood affected. This street did not have any pre-flood data. The graphical representations of deflection versus chainage (Figure 5.26) and strength versus chainage (Figure 5.27) indicate that deflection values were lower and modified structural number was higher in the pavement section that was not flooded when compared to the section that was flooded.

Figure 5.26: Maximum deflection at different chainages on Sutton Street, Chelmer

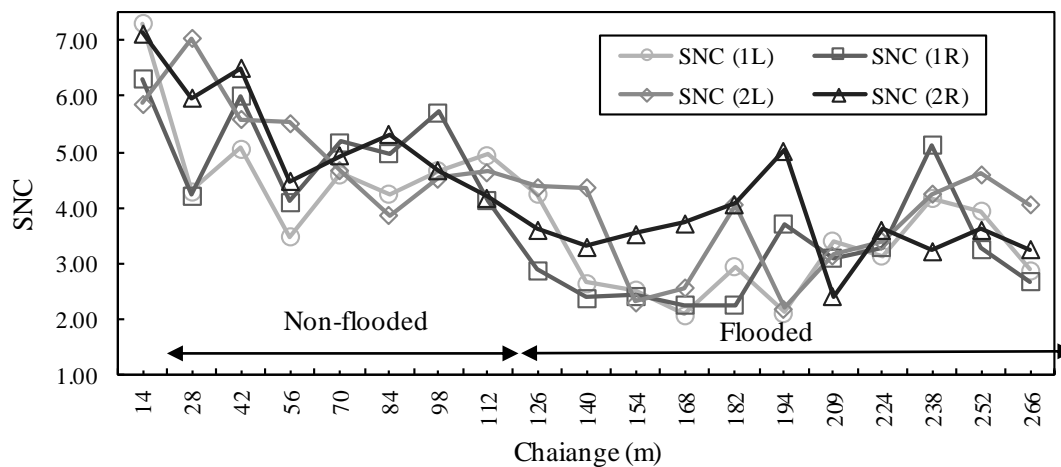
Figure 5.27: Modified structural number at different chainages on Sutton Street, Chelmer

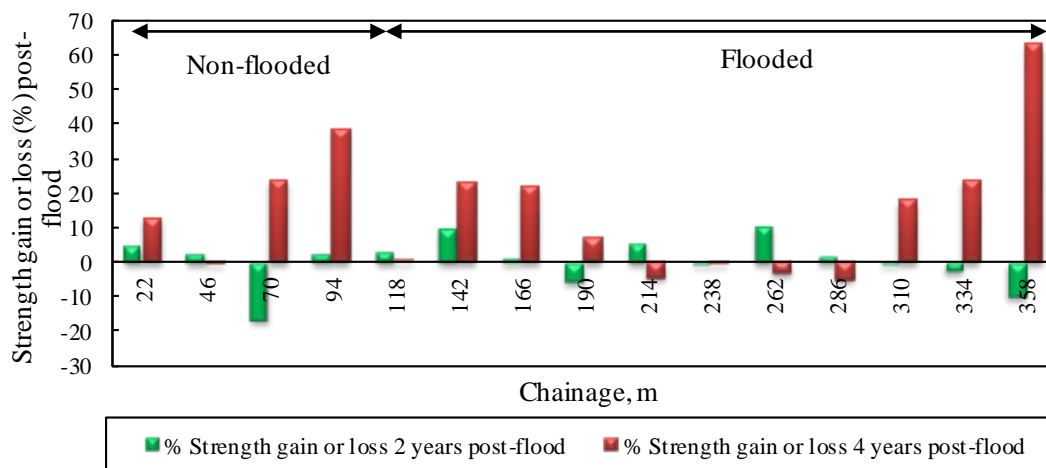
In the non-flooded zone, data collected 4 years post-flood indicated that four testing points in both lanes gained strength, e.g. 10% to 31% in 2L and 0.5% to 38.5% in 2R after the 2011 flooding event. In the flood affected zone, strength gain varied from 1.6% to 45% (all sections) in the inner wheel path and reduction in strength was 6.7% to 63% (6 sections) in the outer wheel path.

Figure 5.32: Post-flooding strength gain of Aldersgate Street, Oxley (outer wheel path [2R])

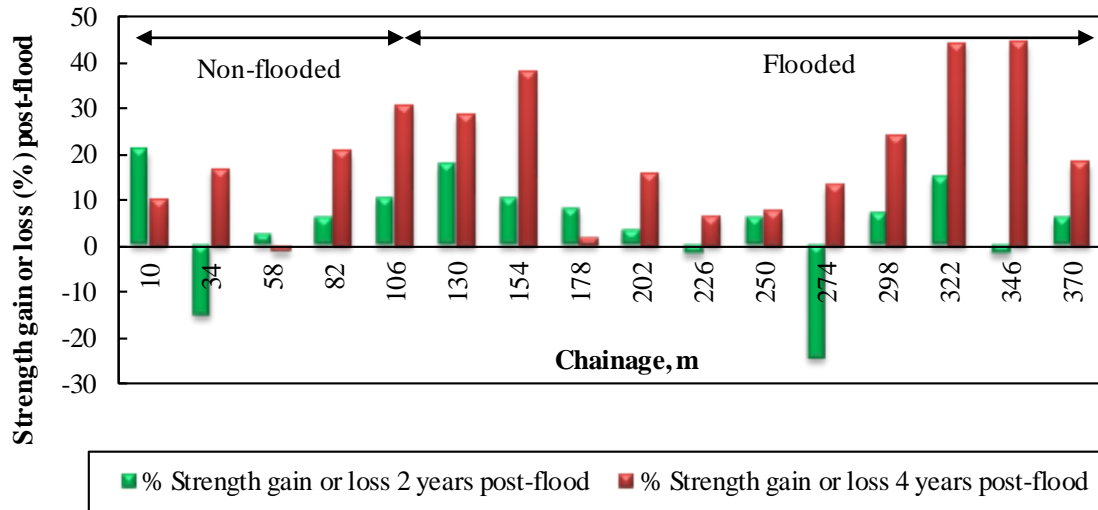
Figure 5.33: Post flooding strength gain of Aldersgate Street, Oxley (inner wheel path [2L])

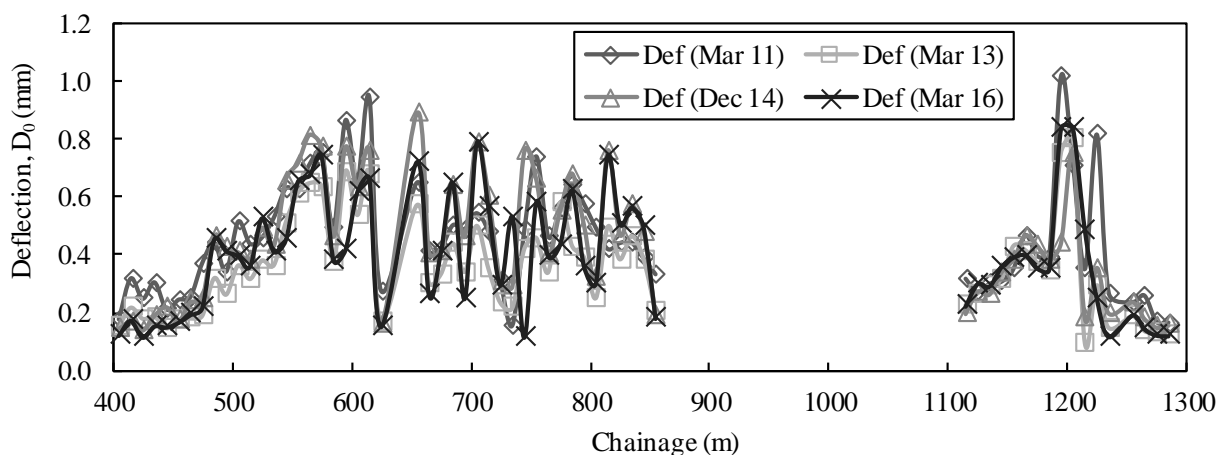
FWD data were collected in 2011, 2013, 2014 and 2016. Deterioration of structural condition in the inner and outer wheel paths of Cordelia Street immediately after the January 2011 flood, in 2013, 2014 and 2016 are presented in Figures 5.34 to 5.37. A comparison of the 2011 and 2013 data indicates that pavement sections had lower maximum deflection ( $D_0$ ) and higher SNC values in 2013 than in 2011. However, many chainage points between 400 m and 850 m had higher maximum deflection and lower SNC values in 2014. Further investigation of these chainages indicates that some sections of the road had loss of surface condition. As a result of the deterioration, part of the pavement section was rehabilitated again in 2015.

Figure 5.34: Maximum deflection at different chainages (inner wheel path [1R]) of Cordelia Street, South Brisbane

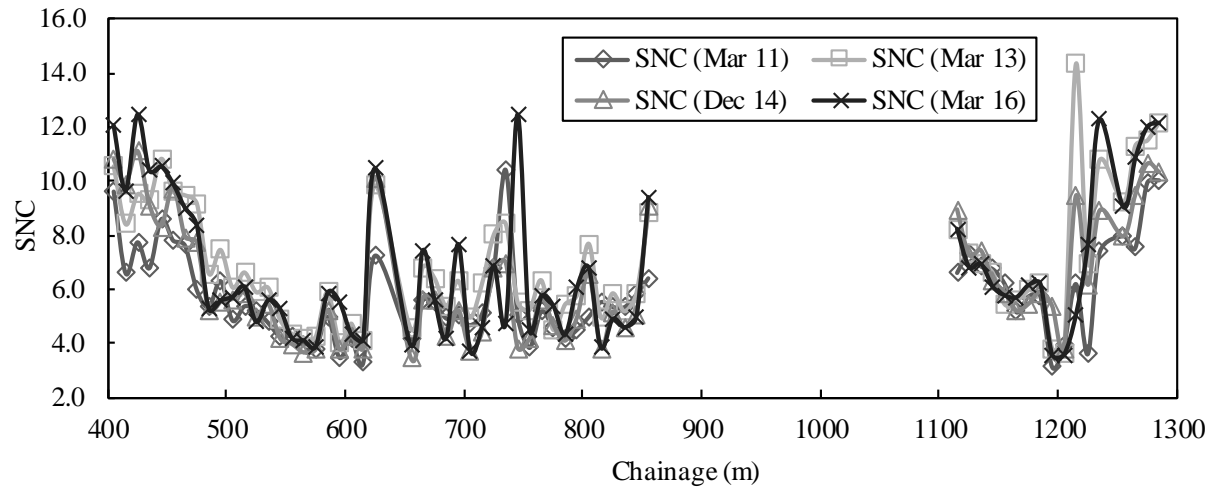
Figure 5.35: SNC at different chainages (inner wheel path [1R]) of Cordelia Street, South Brisbane

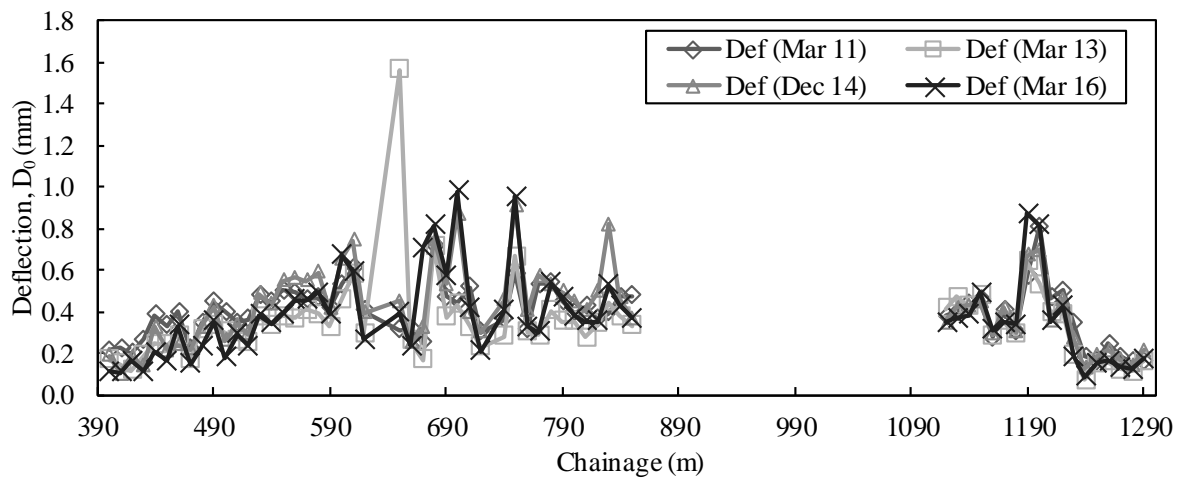
Figure 5.36: Maximum deflection at different chainages (outer wheel path [1L]) of Cordelia Street, South Brisbane

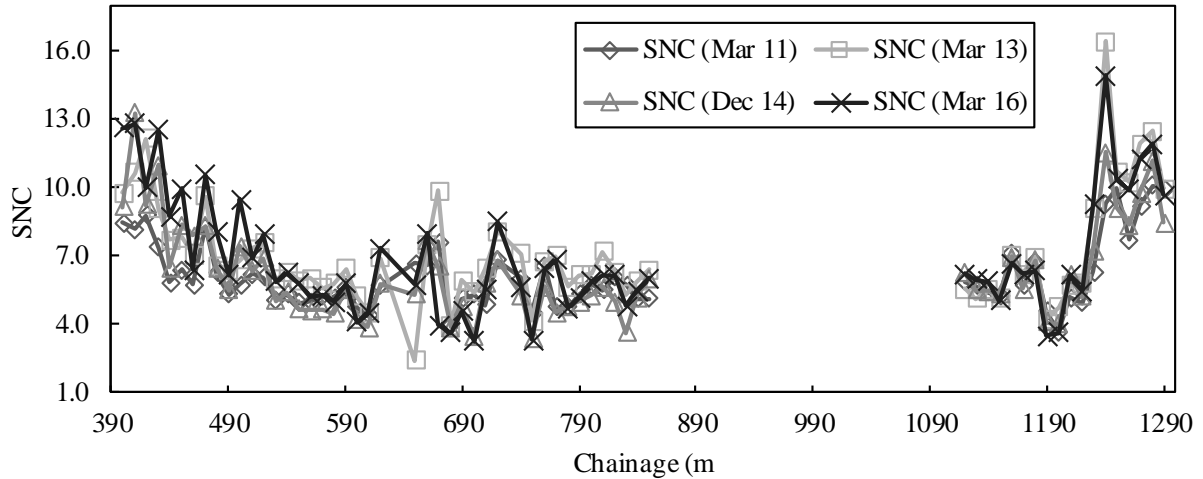
Figure 5.37: SNC at different chainages (outer wheel path [1L]) of Cordelia Street, South Brisbane

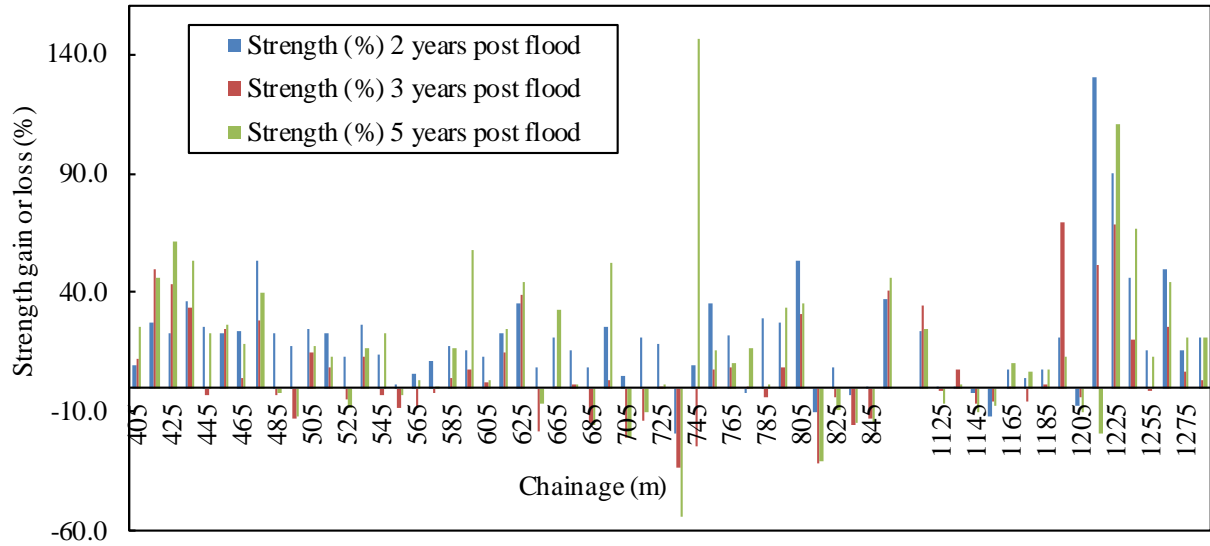
Figure 5.38: Post-flooding strength gain at different chainages (inner wheel path [1R]) of Cordelia Street, South Brisbane

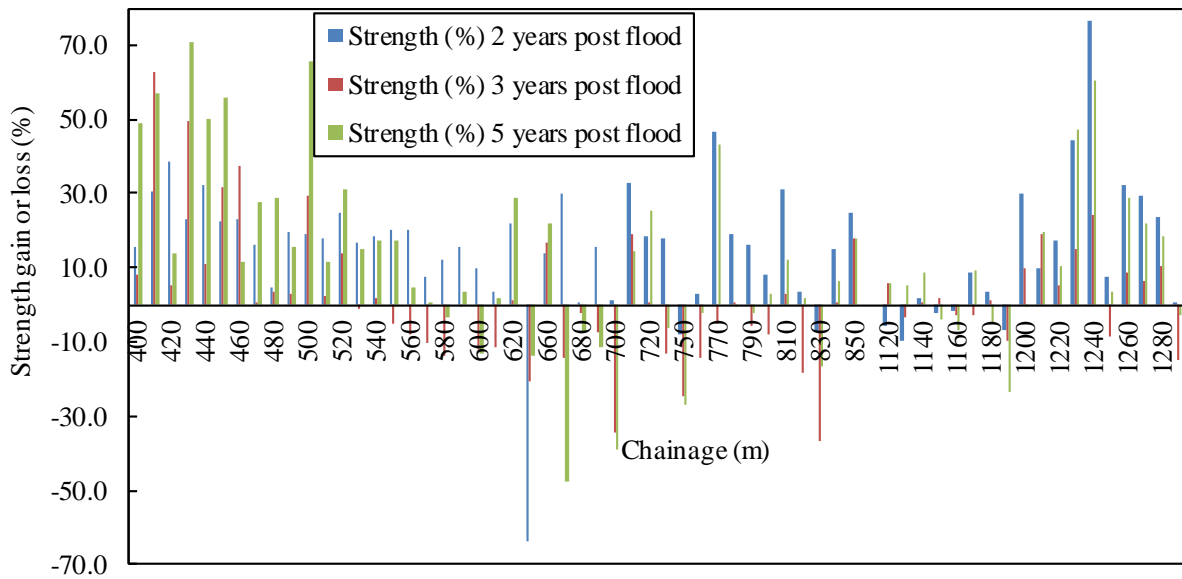
Figure 5.39: Post-flooding strength gain at different chainages (outer wheel path [1L]) of Cordelia Street, South Brisbane

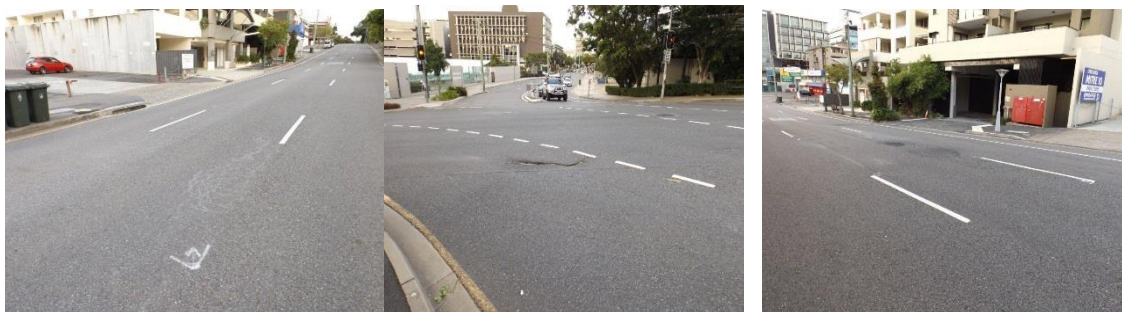
Figure 5.40: Deterioration of surface condition and pavement repair of flood affected parts of Cordelia Street, South Brisbane (pictures taken in 2015)
