## **Assessment and Modelling Deterioration of Flood Affected Pavements**

# **ASSESSMENT AND MODELLING DETERIORATION OF FLOOD AFFECTED PAVEMENTS**

A thesis Submitted in fulfilment of the requirements of the degree of

Griffith School of Engineering, Gold Coast Campus

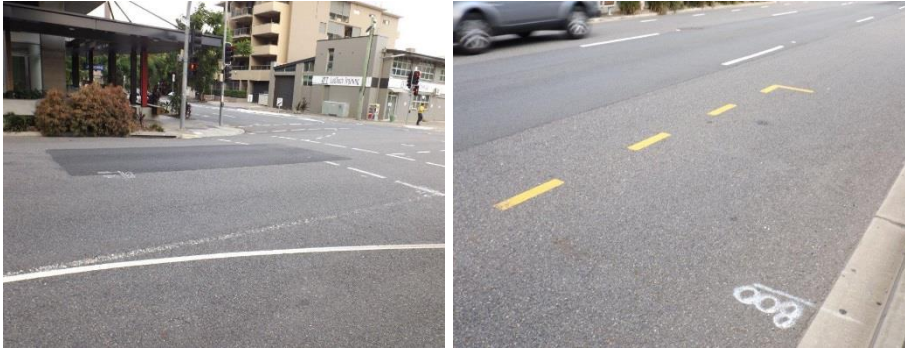
Figure 5.41: Pavement repairs due to surface condition deterioration of flood affected parts of Cordelia Street, South Brisbane

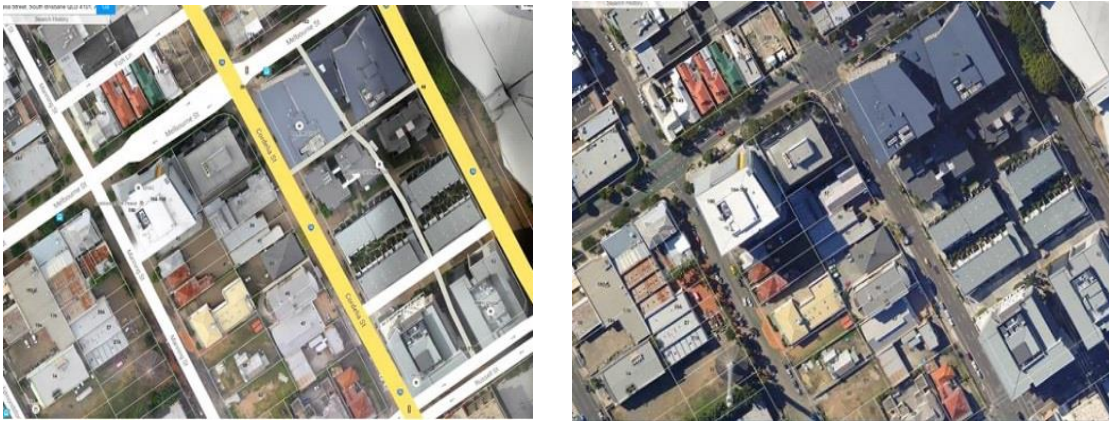
Figure 5.42: Location of flooding on 13 January, 2011 (yellow sections) and small pavement repair by 11 September, 2011 (Aerial image)

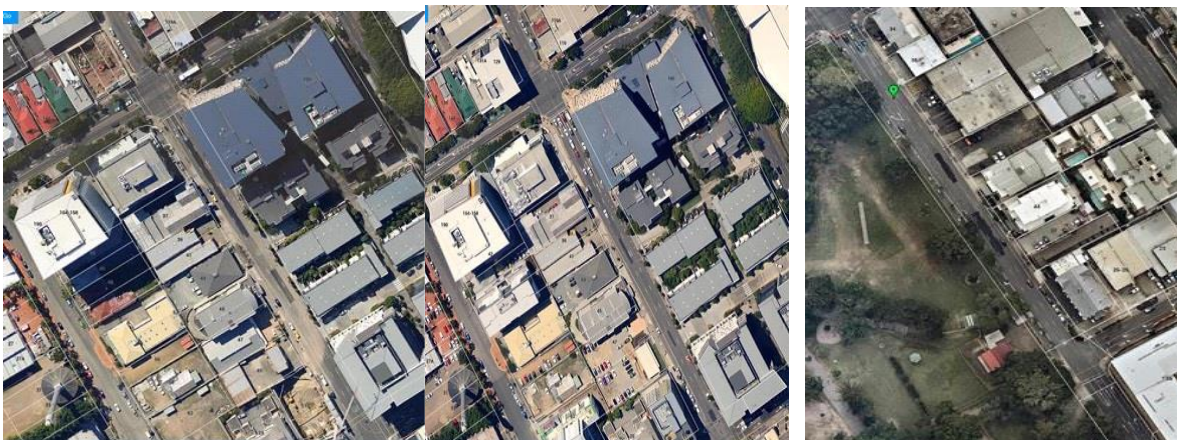
Figure 5.43: Large pavement repairs by 2 September, 2012, additional pavement repairs by 15 October, 2014, pavement repairs by 31 May, 2015 (Aerial image)

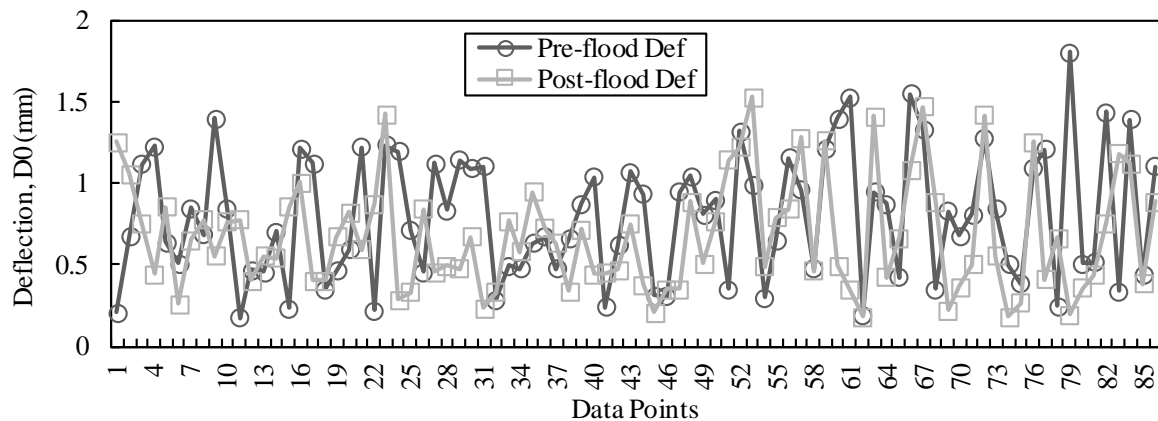
Figure 5.44: Pre- and post-flood deflection data of Sturt Highway, RMS NSW

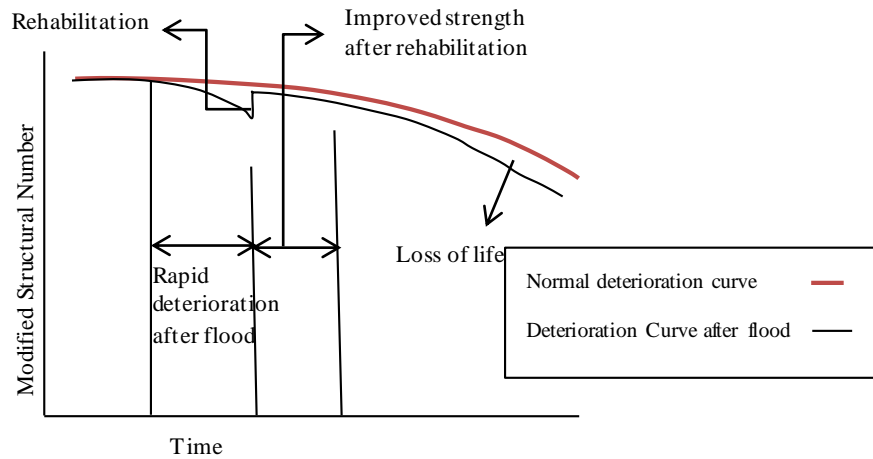
Figure 5.45: Scenario 1- Schematic diagram of the assumption that the road was rehabilitated after the flood and an incremental strength gain occurred due to rehabilitation; it did not regain the post-flood strength

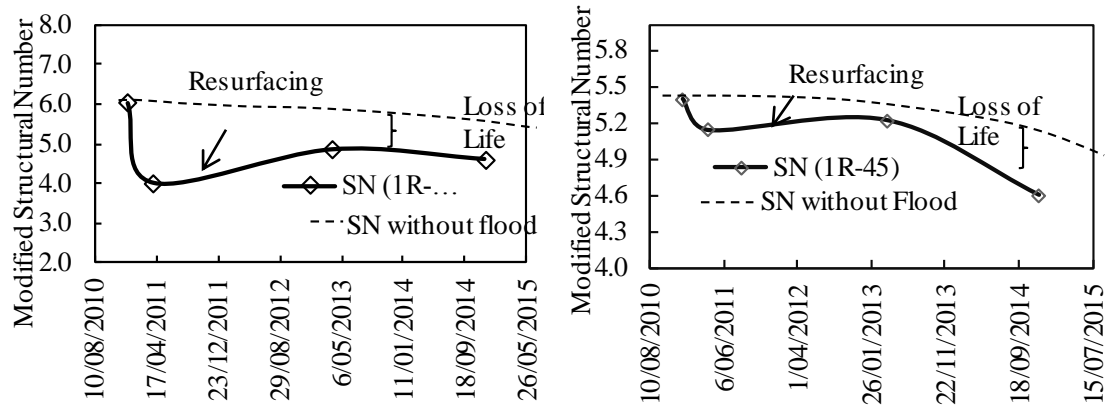
Figure 5.49. Comparison of deterioration of structural strength of an industrial road (Scenario 1)

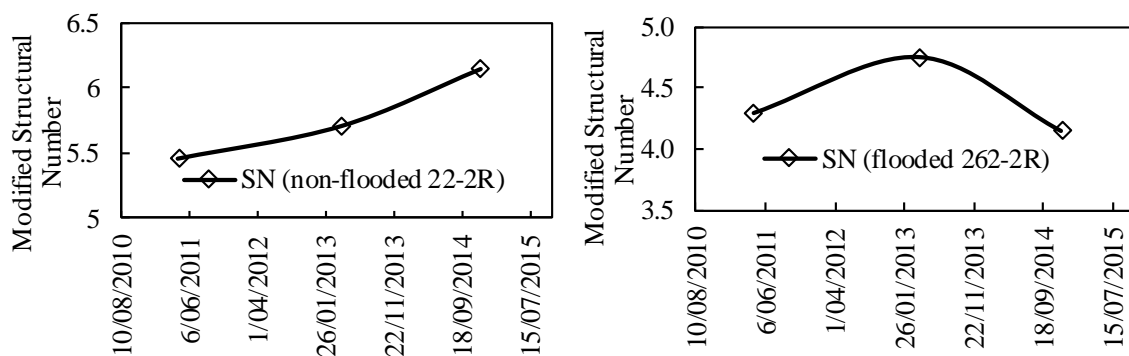
Figure 5.50. Strength curve of non-flooded and flooded section of a lightly trafficked road without rehabilitation (Scenario 2)

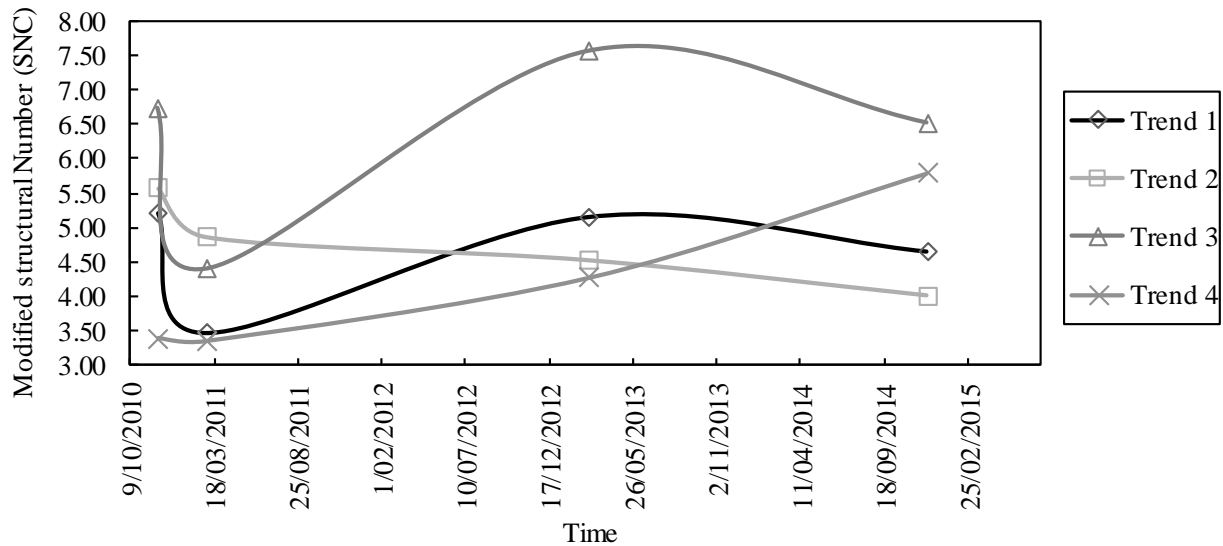
Figure 5.52. Deterioration trends for different sections of a flood affected pavement

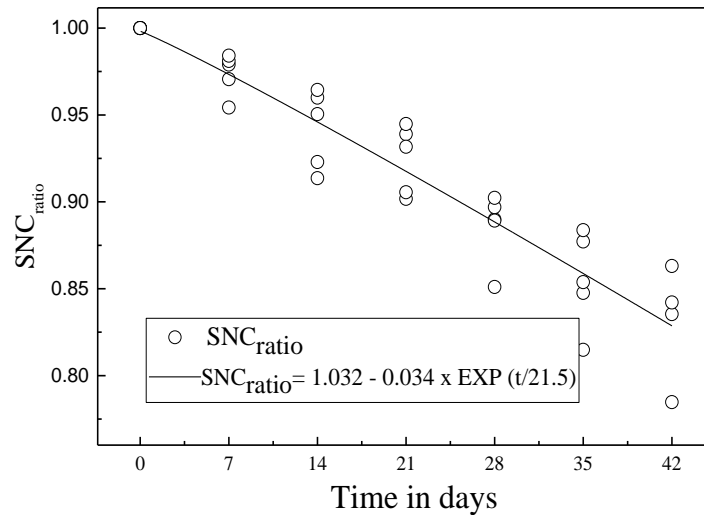
Figure 5.53: Decrease in structural strength within 42 days after flood

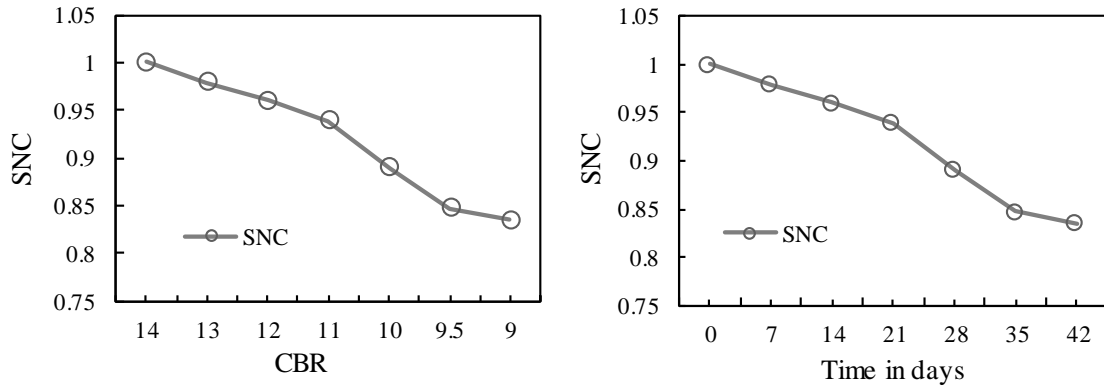
Figure 5.54: Deterioration curve for loss of structural and subgrade strength

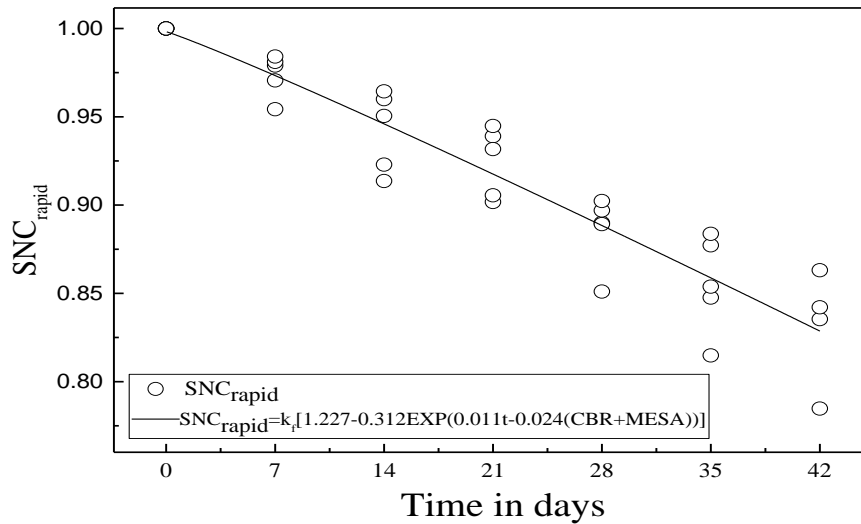
Figure 5.55: Rapid deterioration of structural strength within 42 days of flood

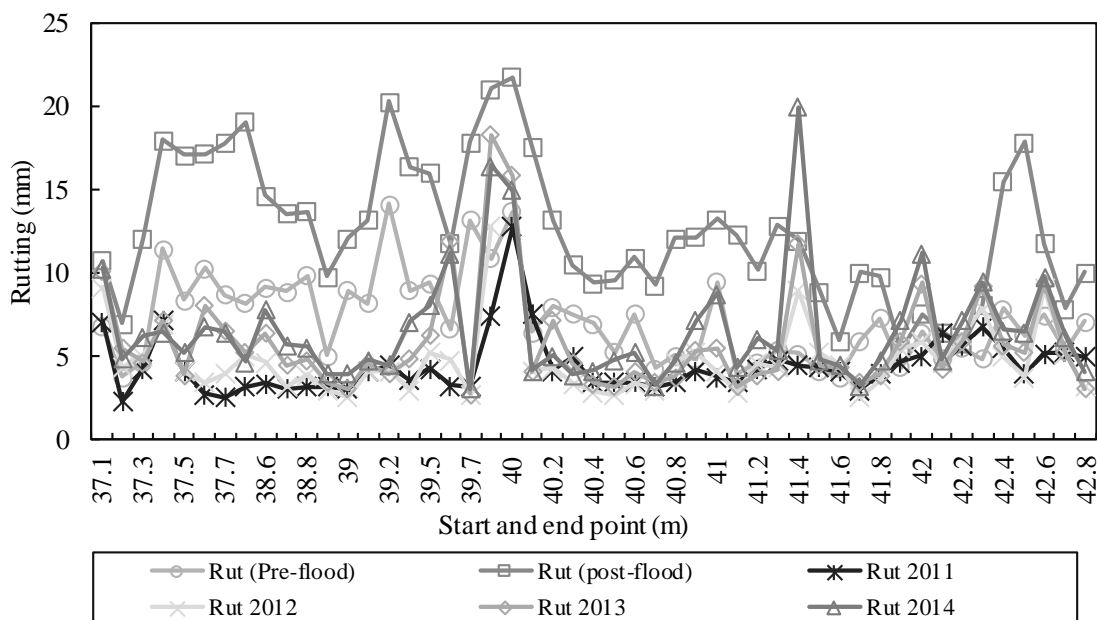
Figure 6.1: Rutting plot for flood affected rehabilitated sections of Rockhampton Emu Park Road (ID: 194), Livingstone Shire Council, Central Queensland

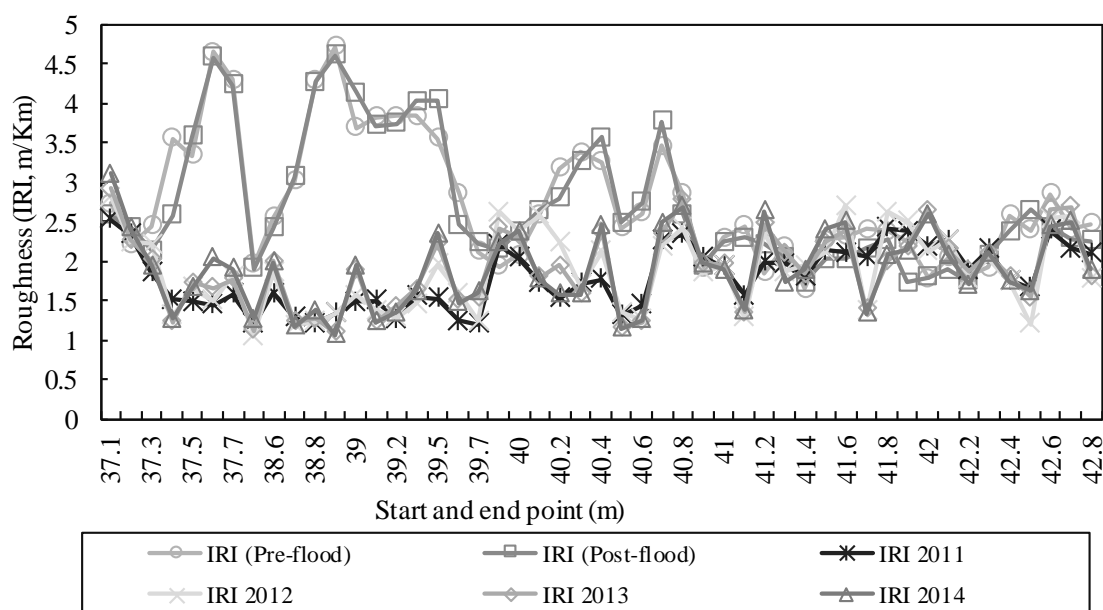
Figure 6.2: Roughness plot for flood affected rehabilitated sections of Rockhampton Emu Park Road (ID: 194), Livingstone Shire Council, Central Queensland

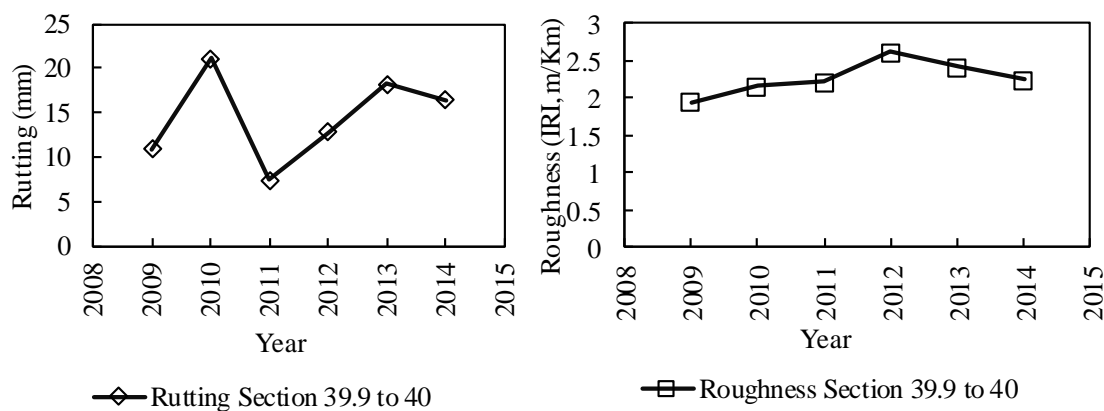
Figure 6.3: Loss of rutting and roughness in section 39.9-40 of Rockhampton Emu Park Road, Livingstone Shire Council, Central Queensland

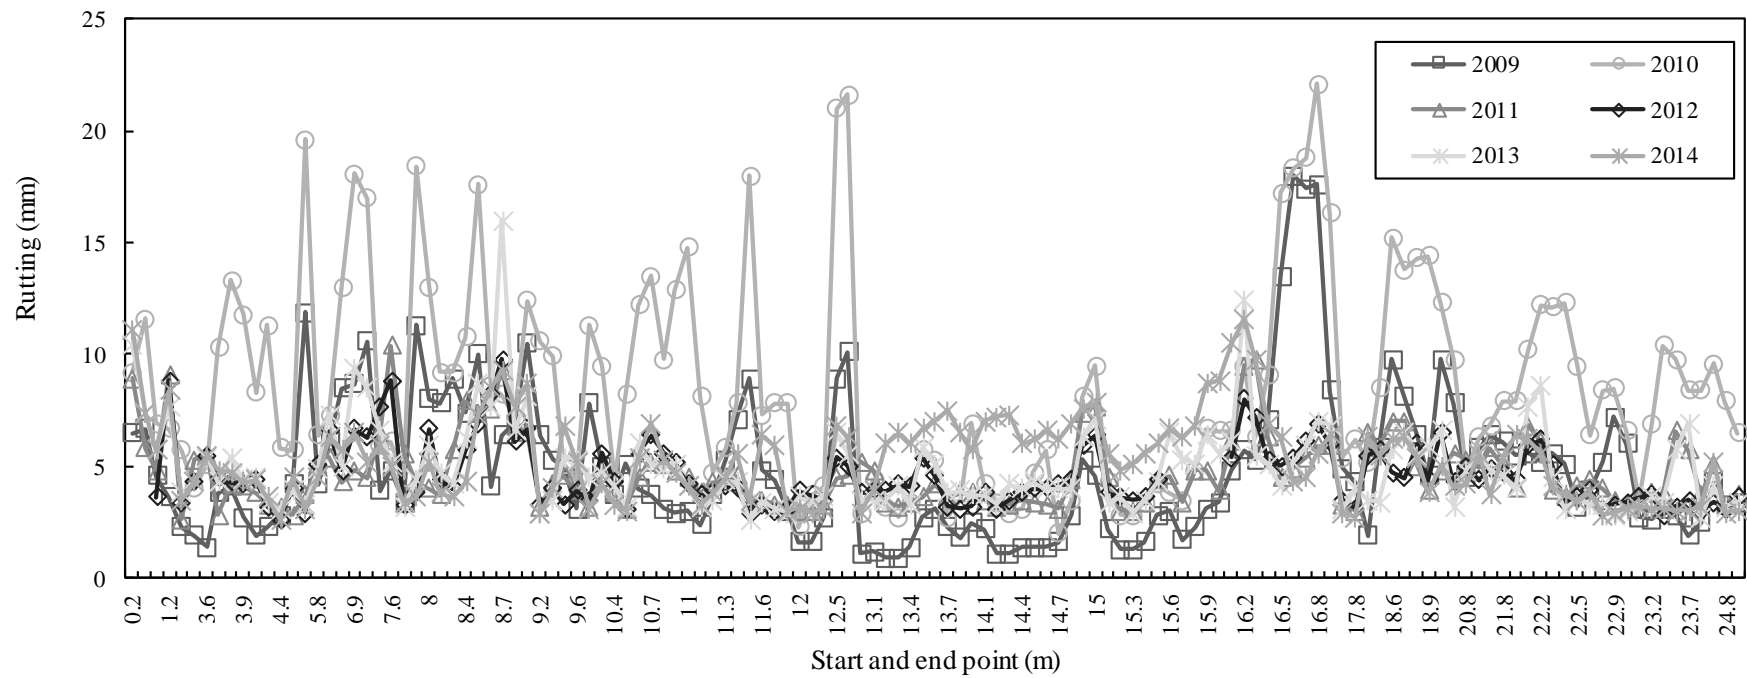
Figure 6.14: Rutting plot for flood affected rehabilitated sections of Bajool Port Alma Road, Rockhampton Regional Council

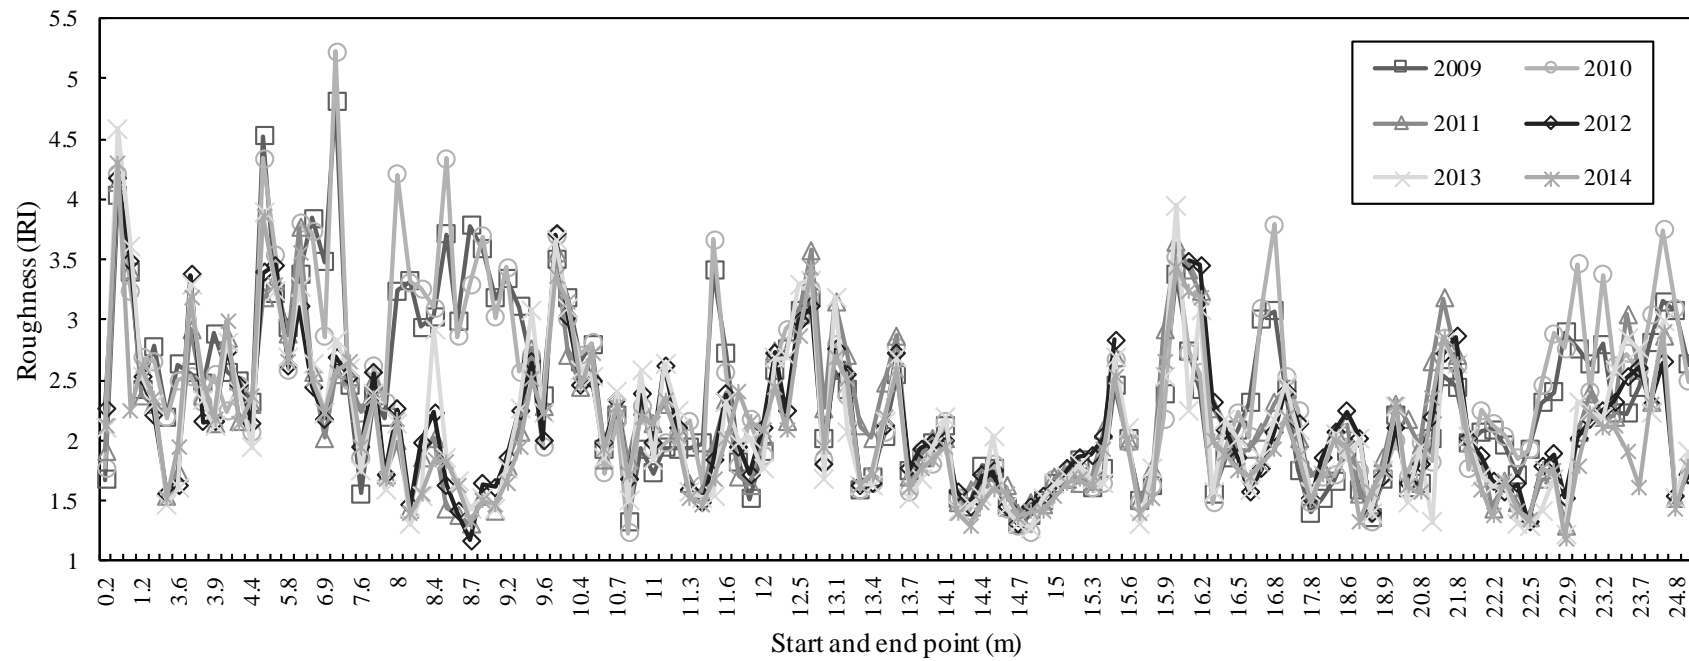
Figure 6.15: Roughness plot for flood affected rehabilitated sections of Bajool Port Alma Road, Rockhampton Regional Council

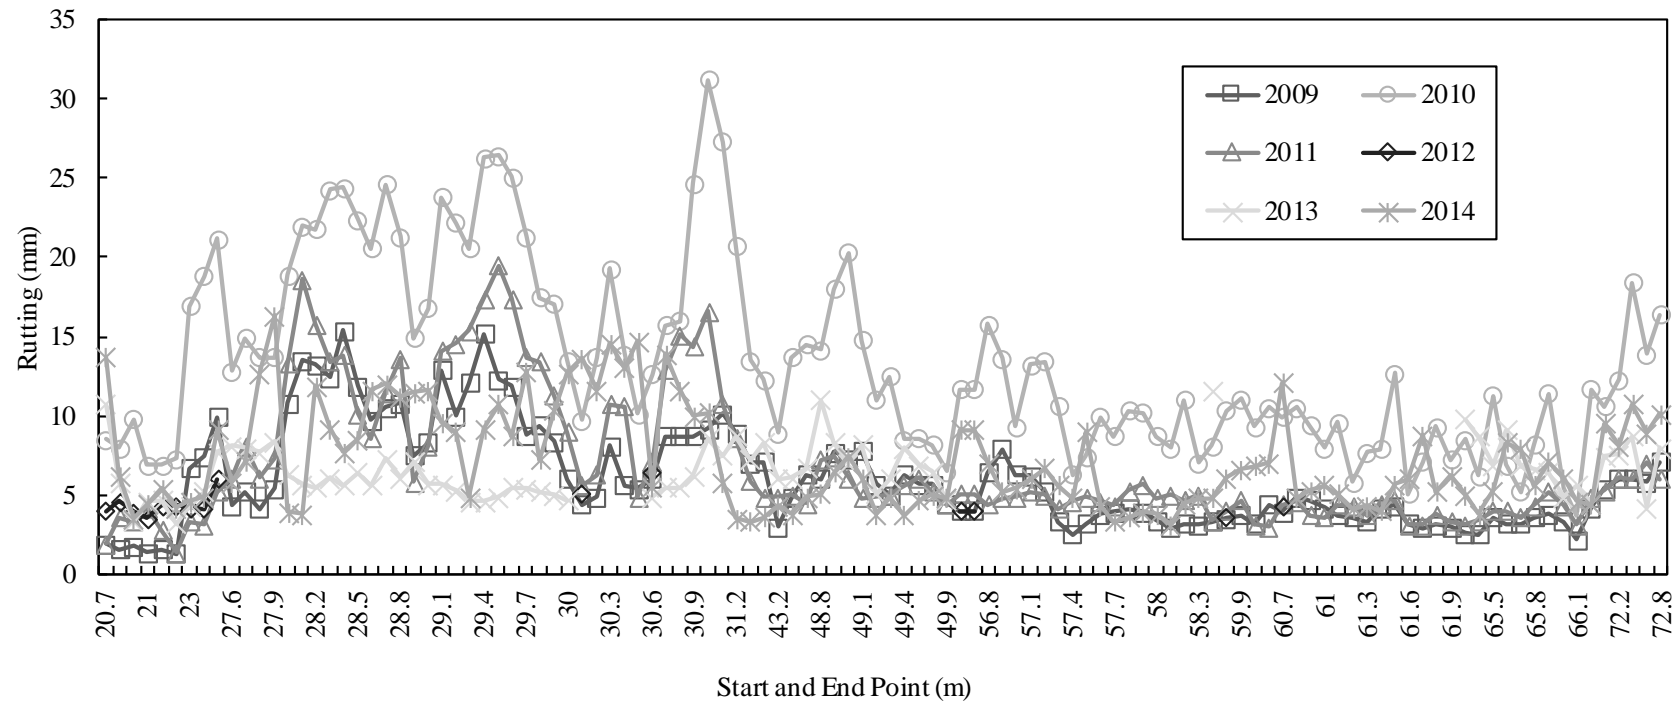
Figure 6.16: Rutting plot for flood affected rehabilitated sections of Gladstone Biloela in Dawson Highway, Gladstone

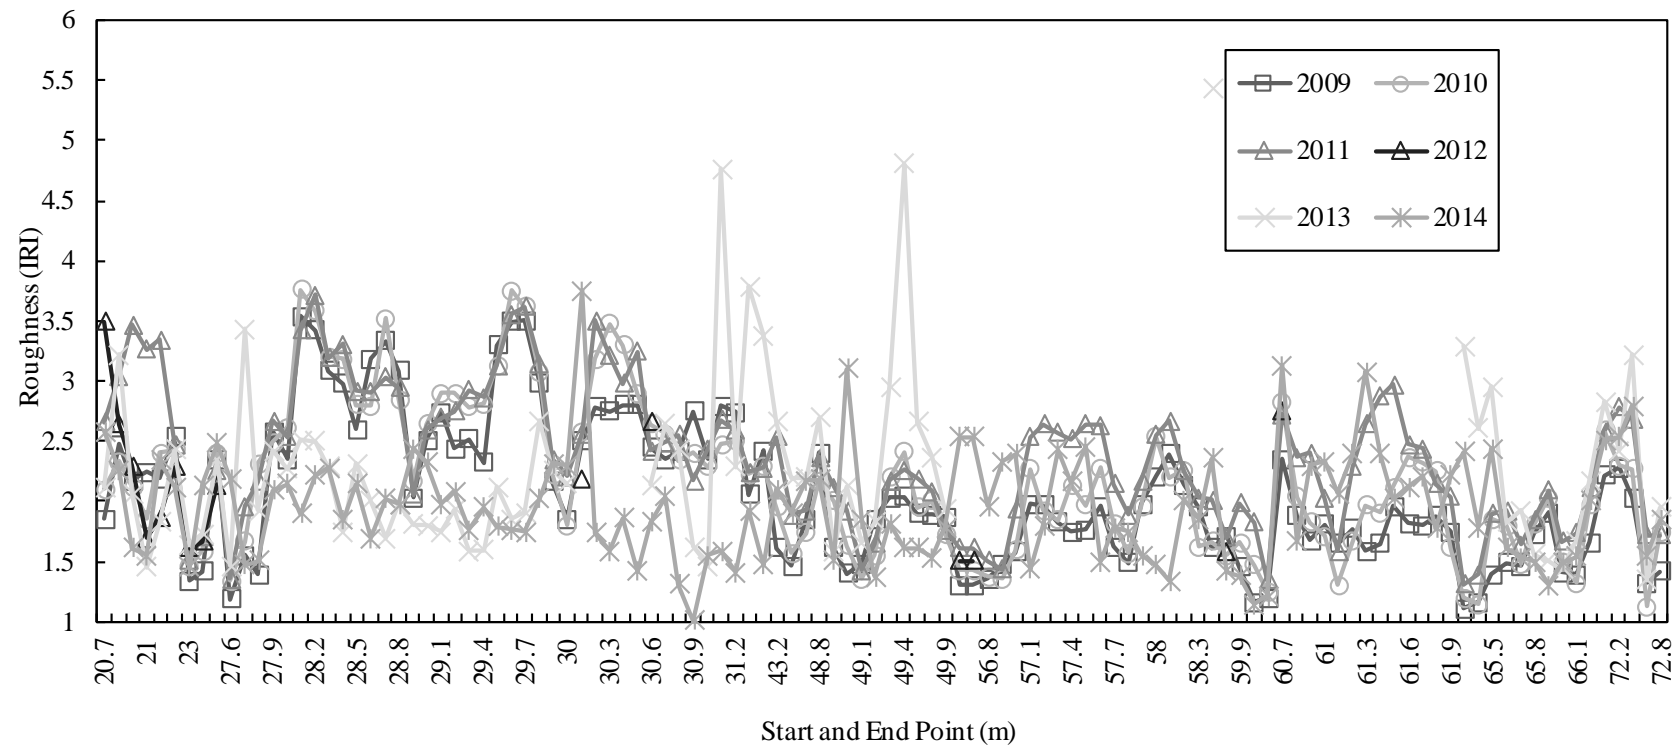
Figure 6.17: Roughness plot for flood affected rehabilitated sections of Gladstone Biloela in Dawson Highway, Gladstone

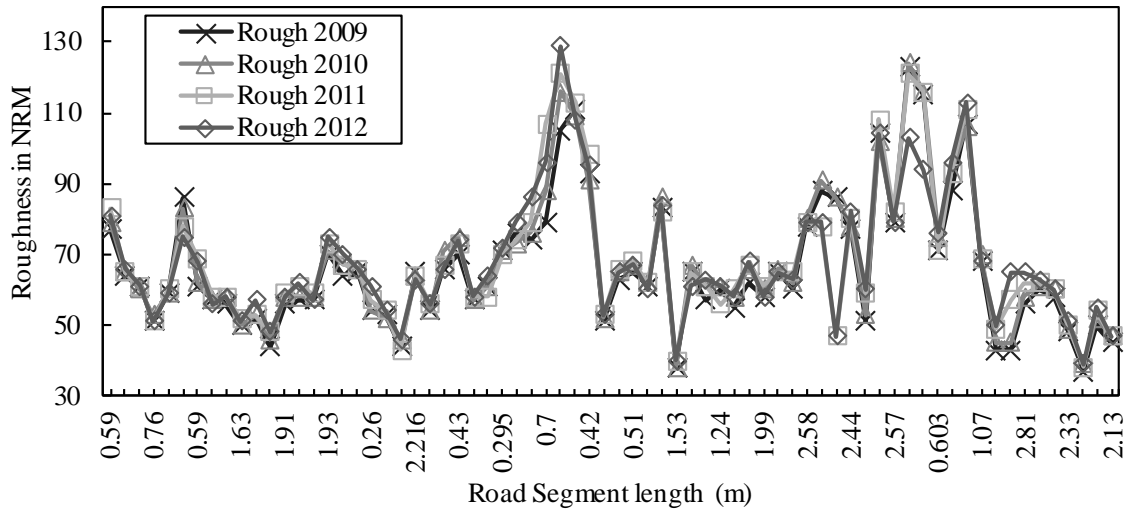
Figure 6.18: Comparison of pre- and post-flood roughness data of Sturt Highway, RMS NSW

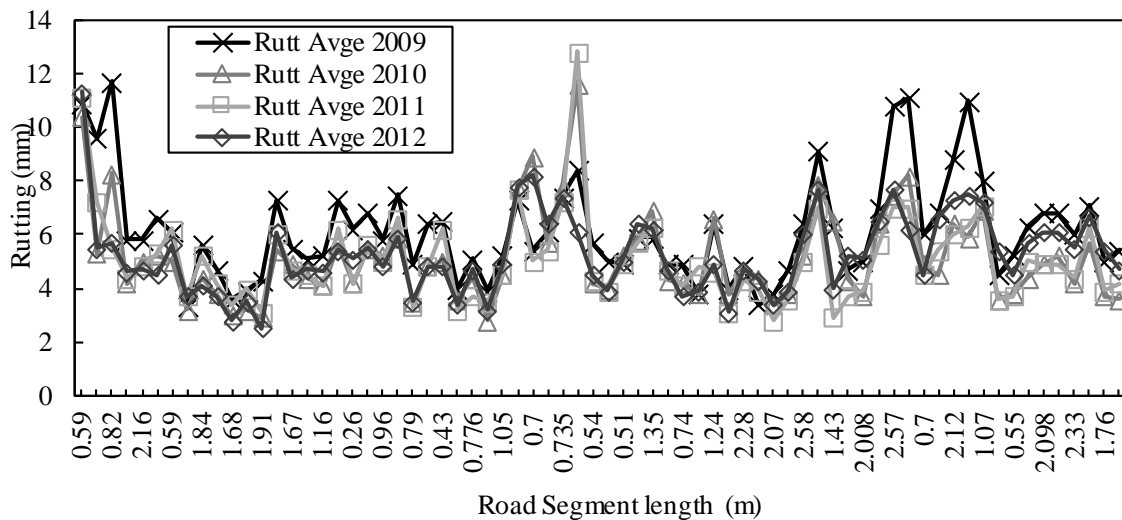
Figure 6.19: Comparison of pre- and post-flood rutting data of Sturt Highway, RMS NSW

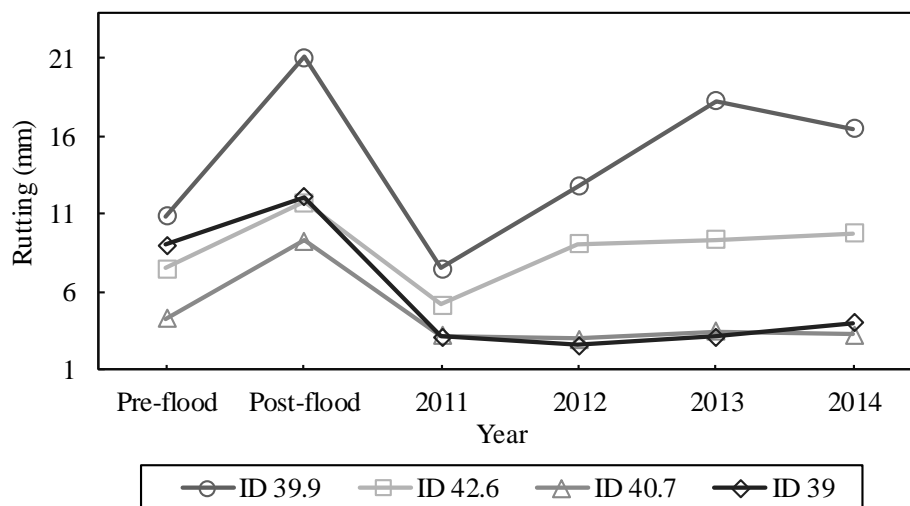
Figure 6.20: Rutting progression from 2009-2014 in Rockhampton Emu Park Road

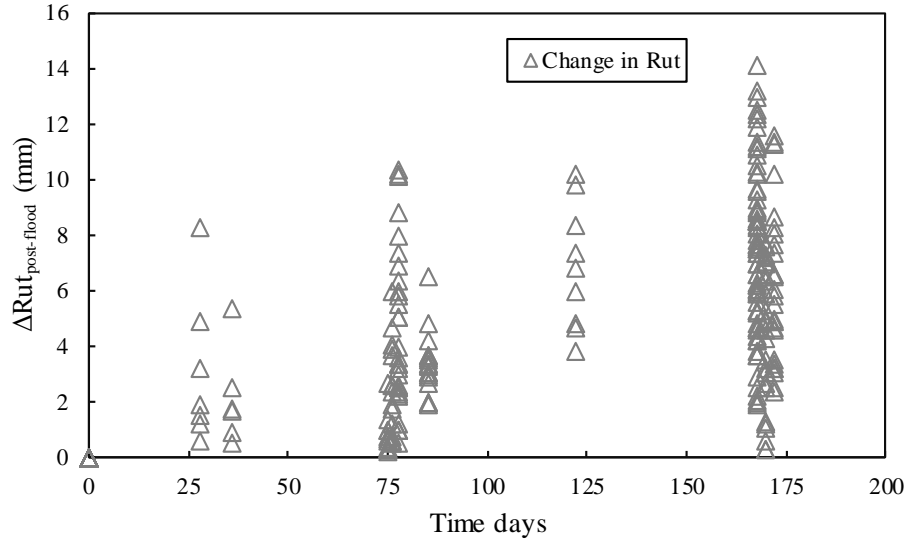
Figure 6.25:  $\Delta R_{ut\_post-flood}$  vs time

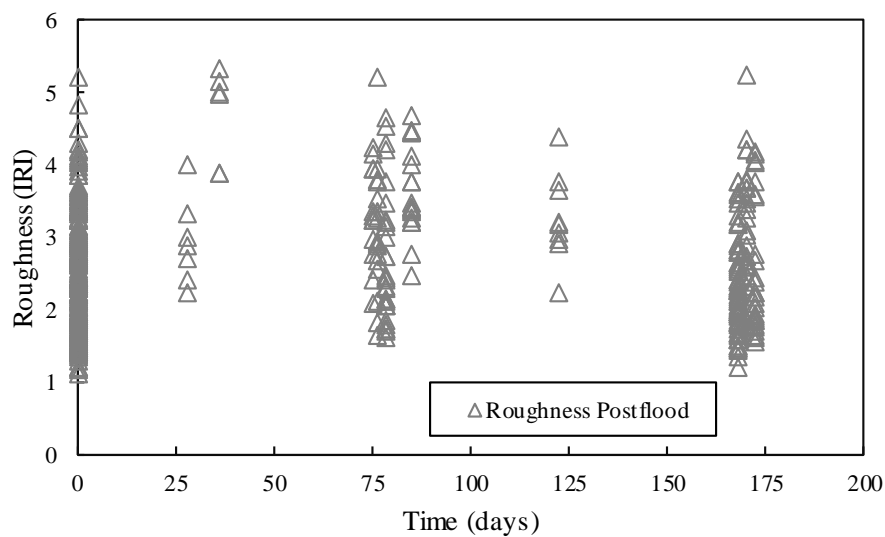
Figure 6.26: Pre- and post-flood roughness vs time
