Tanna Island Safehouses and Mini Power Systems Status Update December 2019

Melissa Jackson¹, Prof Rodney Stewart¹ & Prof Brendan Mackey²

School of Engineering and Built Environment/Cities Research Institute¹
Griffith Climate Change Response Program²
Griffith University, Queensland Australia

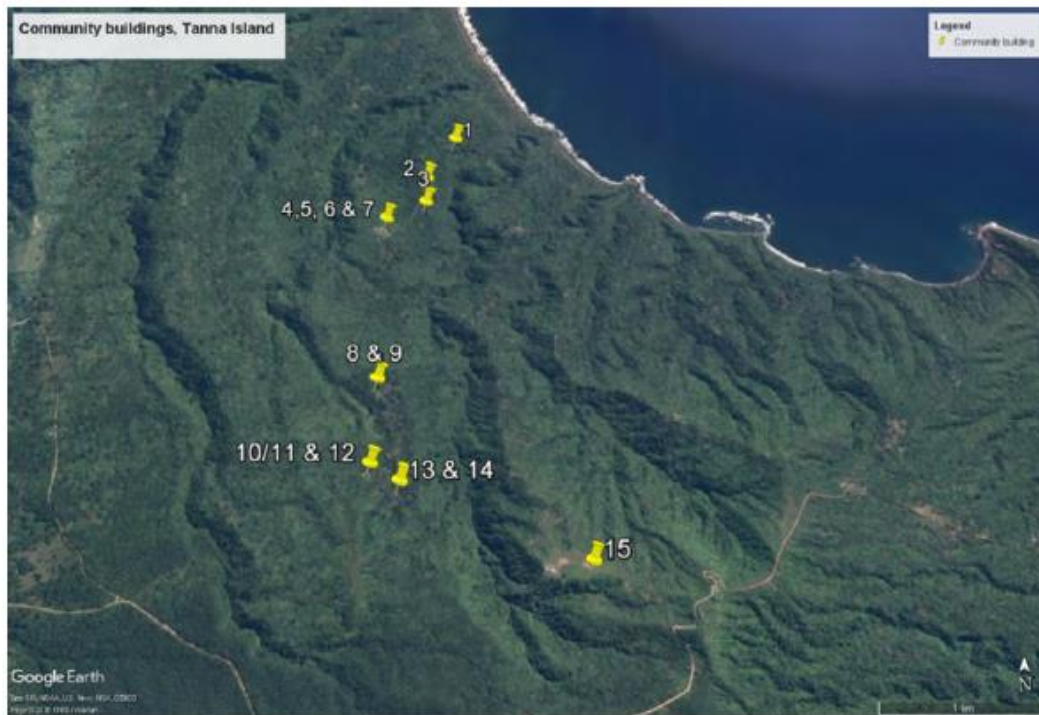
Figure 1 - Tanna Safehouses location of hut and power systems

Of the thirteen huts with the smaller systems, only four power systems were functioning – at buildings 1,2, 5 and 12 (see Figure 1). This is down from six that were still functioning in June 2019 (see *Tanna Safehouses and MPS Audit Report July 2019* for details).

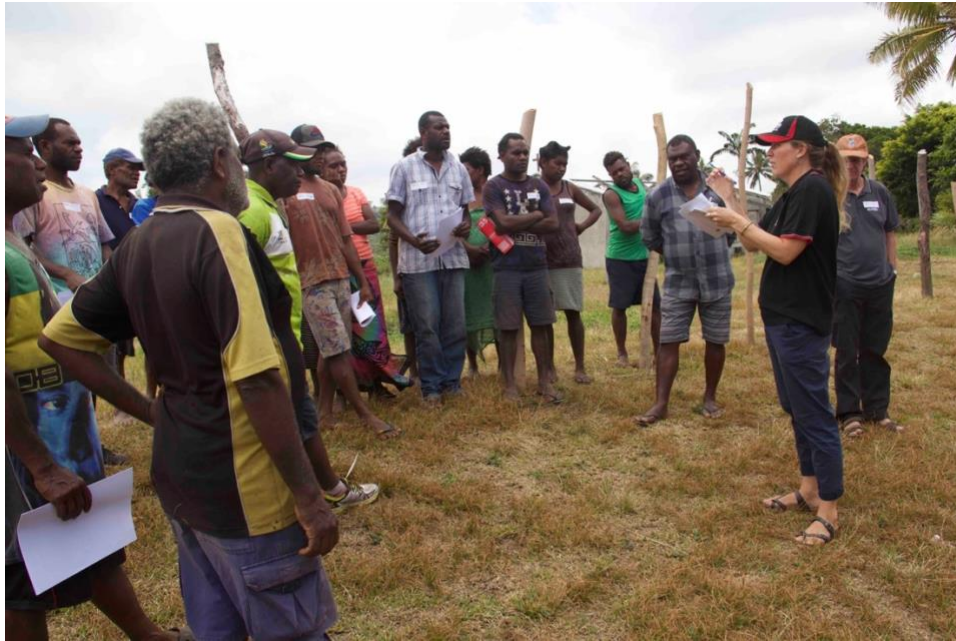
Figure 3 Practical training given at the site of the power systems

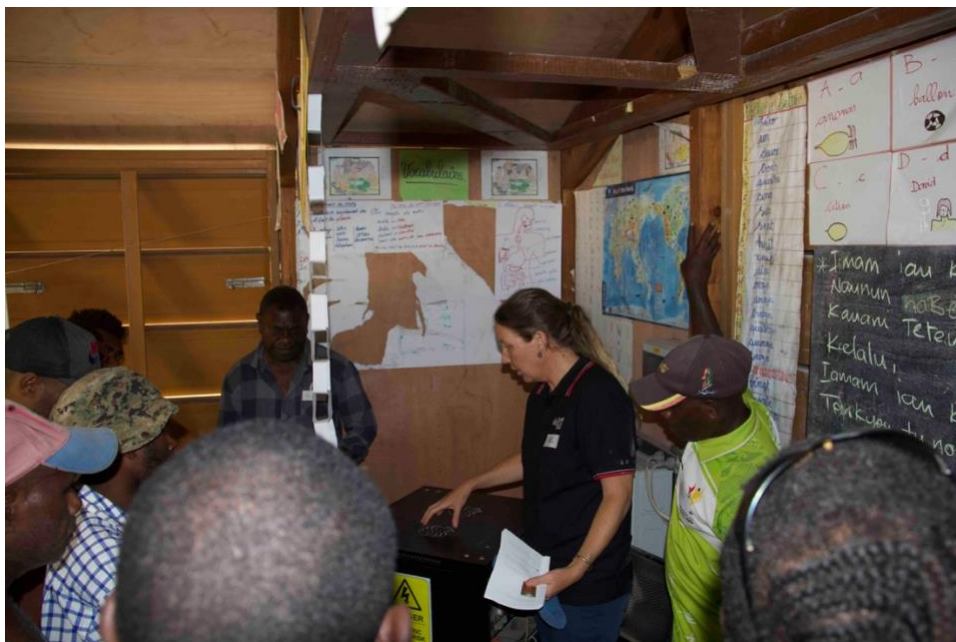
Figure 4 Melissa Jackson, Tim Loughman and Allan Dan teaching community members about basic functions of the solar power system

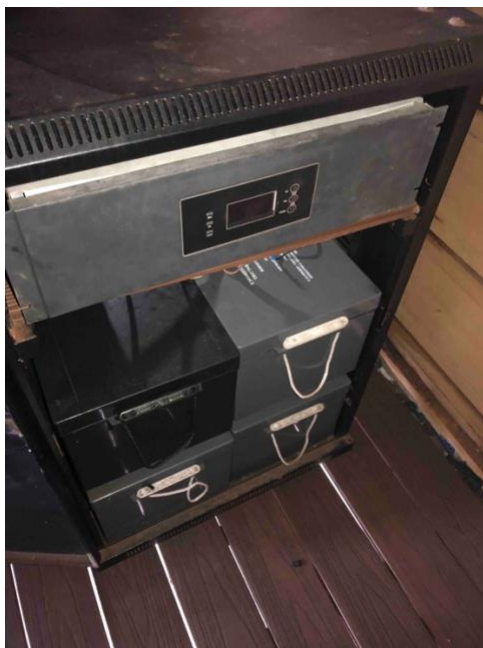
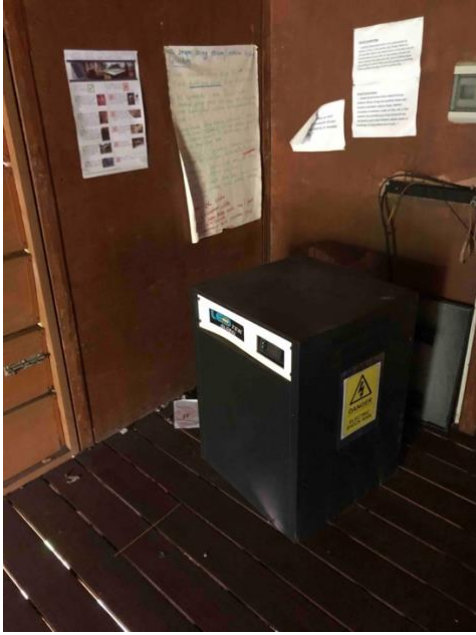
Figure 7 Three different displays/user interface of mini power systems provided by Green NRG

- At least three of the systems have different LCD screens and user interfaces (Figures 7a, 7b, 7c), however the User manual provided by GNRG, is different to these interfaces and thus the community summary guide designed based on the information provided by GNRG (to clearly indicate how community members can navigate and diagnose basic issues via these interfaces) are not accurate. GNRG need to provide exact user manual instructions for each different model of 5KW system to Griffith researchers for inclusion in the guides prior to translation taking place.

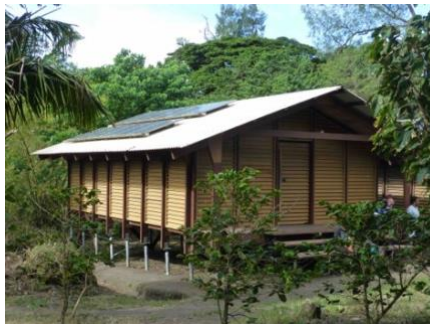
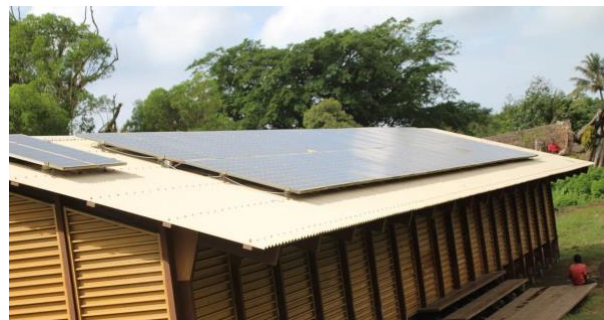
Solar panels

On the roof of each building is an array of solar panels. Each panel is made up of between 60-72 solar cells that convert sunlight into electrical energy. The energy travels down the wires into the main system and inverter.

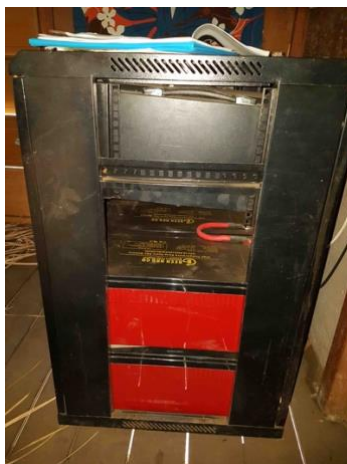
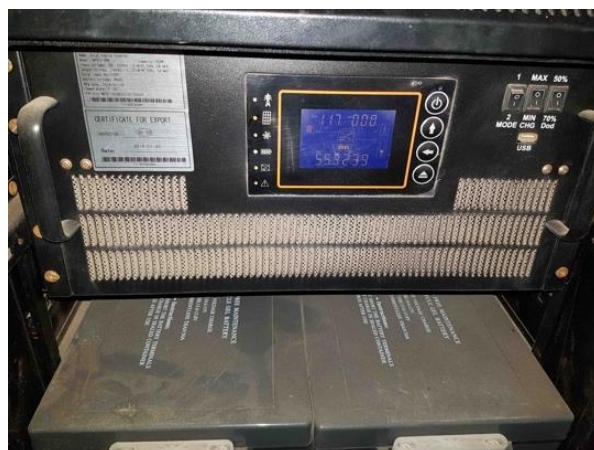
Inverter and control panel

The inverter changes the electrical energy from the panels into a form that appliances run on e.g. phones, computers; termed AC or Alternating Current. Inside the mini power system cabinets the inverter and controls are on top with four batteries below.

The LCD screen (liquid crystal display) allows query of the status of the power system and you can view real-time power generation. See Appendix A for settings and functions of the LCD screen.

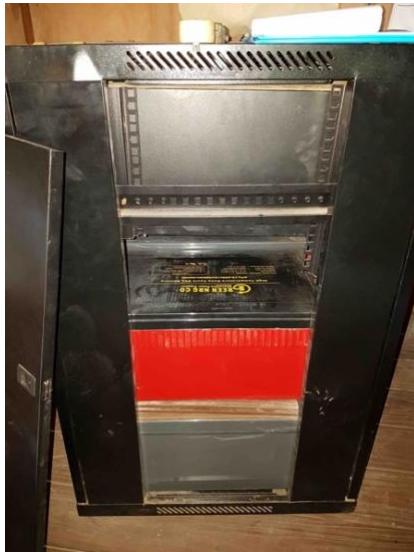
Batteries

When there is no electricity grid in a region, batteries are essential for storing the energy generated by the solar panels during daylight hours, for use at other times. There are four batteries for each 5kW power system (and 16 for the 20kW system stored under the building).

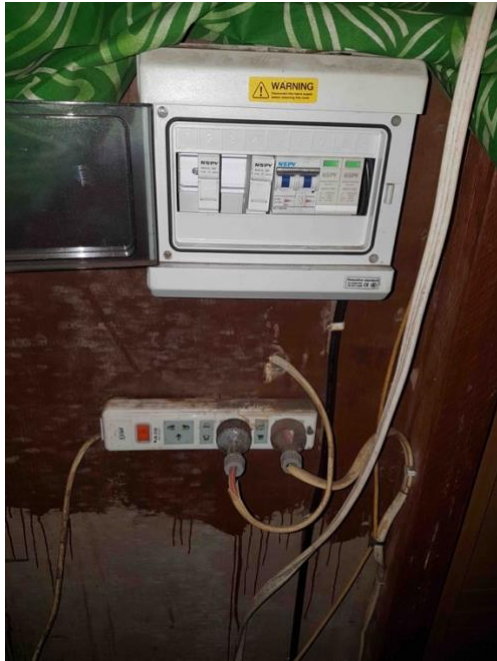
Circuit breaker

There is a fusebox/circuit breaker that will trip (automatically switch off) if the system is overloaded. This protection measure is built in to ensure safety and to avoid overloading or damaging the system, electric shock, or injury to users.

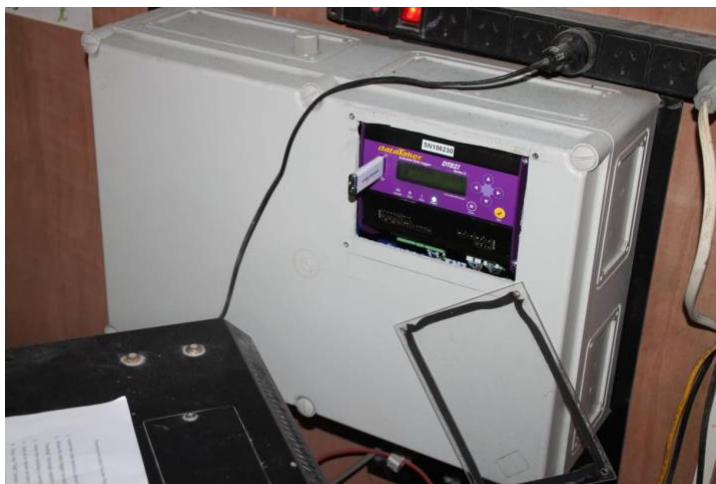
Data logging equipment

In three of the fourteen buildings data logging equipment has also been installed to allow for monitoring of the systems and power use.

DO NOT UNPLUG the data loggers from the powerboard or the data will not be available to monitor the system.

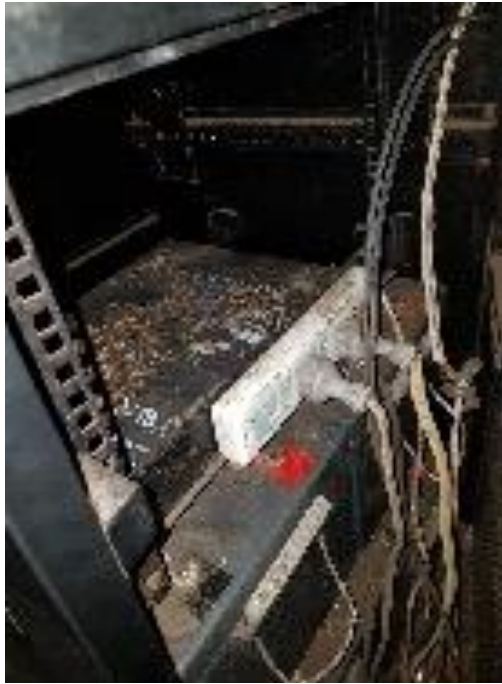
Do not use detergents or corrosive solvents to clean the equipment.
Do not let any liquids flow onto or into the machine.
Ensure the vents of the equipment are not blocked.

Battery life can be extended also through regular use within load limits. Regular use with charge and discharge cycles is important for battery health. Full discharge of batteries (i.e. draining them to empty) regularly should be avoided by monitoring the LCD display panel to check battery status.

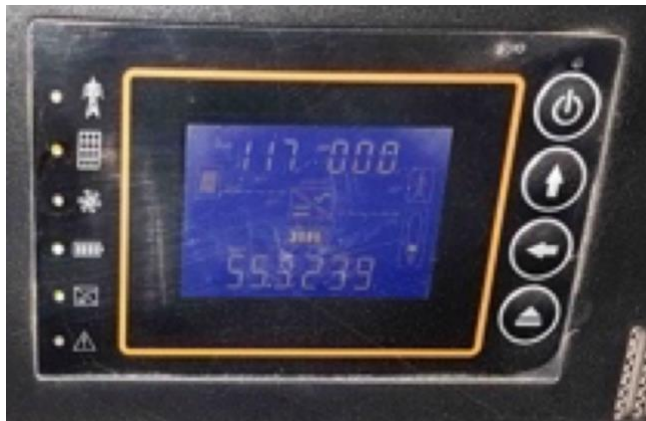
Image of an LCD display from one of the mini power systems installed

i Note the difference between the actual displays and the instruction manual image below due to upgraded technology (e.g. On/Off button along right side rather than below LCD screen), however the functions operate similarly.
