A case study on a fire-induced collapse accident of a reinforced concrete frame-supported masonry structure

Keywords: Frame-supported masonry structure; fire-induced collapse; site investigation; numerical simulation

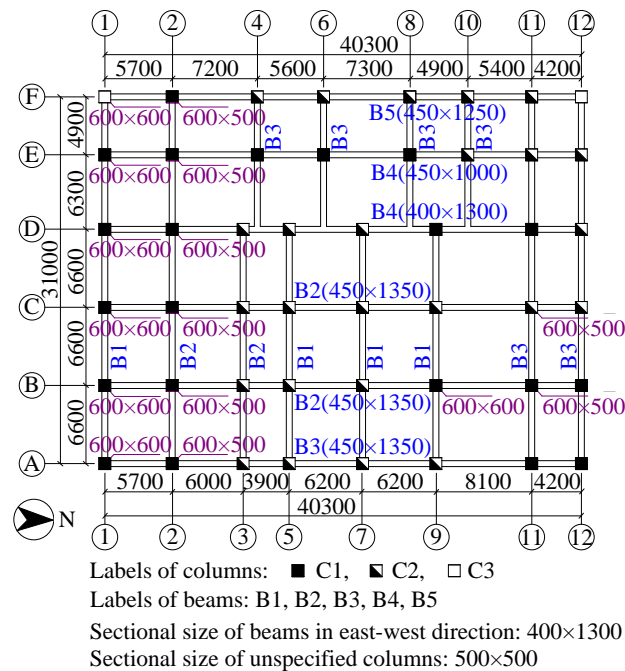
Figure 1 Structural arrangement of the ground floor frame and member sizes (unit: mm)

Based on the degree of damage to the columns and beams, the preliminary site investigation concluded that damage of Columns E-8, E-10, E-11, D-9, and D-11 on the ground floor (refer to Figure 1) occurred due to very high temperature exposure, which is believed to have triggered the progressive collapse of the upper masonry structure. The columns were designed to resist a normal fire in accordance with the requirements of the design code ^[33], regulated for commercial buildings. However the occupation of the ground floor of the building was changed to a warehouse filled with a large amount of flammable materials. Hence, the actual fire load developing at the time of the accident was extremely high, higher than originally considered acceptable in the design. The extraordinary fire load, covering a large area with a very high temperature, is considered to be the primary reason for the initial damage to the ground floor columns. In addition, the spalling of the concrete cover, and the construction error at the connections between the slabs and the RC frame, all accelerated the damaged to the columns.

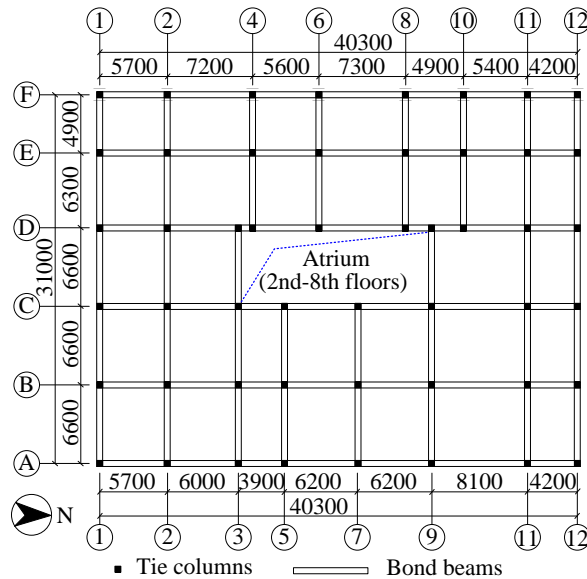
Figure 2 The arrangement of the bond beams and tie columns of the masonry on the first through seventh floors (unit: mm)

Figure 6 shows the fire damage to the columns, whose locations are illustrated in Figure 2. The crushed concrete and brownish steel surface of Column D-9, located at the center of the fire, indicated that the cross-section of the concrete column suffered severe high-temperature damage. Column E-2, located on the border of the high temperature area, suffered spalling of the concrete, buckling of the longitudinal reinforcement, and compressive failure as clearly shown in Figure 6(b).

Figure 7 shows severe damage to the beams located at the center of the fire. The concrete cover of Beam 8-E~F (refer to Figure 2) fell off, causing the exposure of the stirrups and the longitudinal reinforcing steel. Subsequent to the collapse of Beam

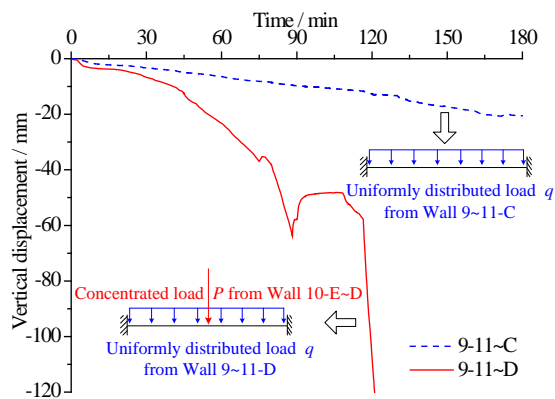
Figure 13 Vertical displacements of the frame beams

and B (see Figure 12). The collapse occurred due to the following three factors. First, the fire temperature in these zones was significantly higher (greater than 800 °C) than the other regions. As shown in Figure 3, Columns D9 and E4 reached a maximum temperature of 1300 °C. Therefore, the fire damage to these two zones was more severe than in the remaining part of the structure. Two, the structural planar layout for Columns D9 and E4 carried a larger gravity load than did the other components (the shaded part of Figure 12), making them more vulnerable to fire. Third, the structural arrangements of Zones A and B were more complex than those of the other areas. The gravity load of the upper walls (4-E~D and 10-E~D), initially acting on the secondary beams, was transferred to the main girders (3~5-D and 9~11-D), and then to the columns. Thus, these structural elements appeared to exhibit more complicated internal force characteristics which were more vulnerable to damaged under the fire condition. Taking Beam 9~11-D and its parallel Beam 9~11-C in Zone A as an example, the vertical displacements and the mechanisms of these two beams, shown in Figure 13, had an identical longitudinal span (8.1m) and supported the slabs with similar widths (12.9m and 13.2m). This situation lead to near uniformly distributed gravity loads q acting on the beams. However, an additional concentrated load P transferred from the upper Wall 10-E~D also acted on Beam 9~11-D. As a result, larger internal forces (i.e. shear force and bending moment) developed in Beam 9~11-D in comparison to Beam 9~11-C, and, in turn, induced a lager deformation, as shown in Figure 13. Moreover, the displacement of Beam 9~11-D reversed at about 88 min.; this was due to the load redistribution of the adjacent columns as a result of the high temperature actions (discussed in the following section). Given the abovementioned reasons, Zones A and B were the most vulnerable regions within the structure to initiate a collapse under fire.
